# **Historic Building Assessment for the Old Stone School**

**353 Nimble Hill Road, Newington, New Hampshire**

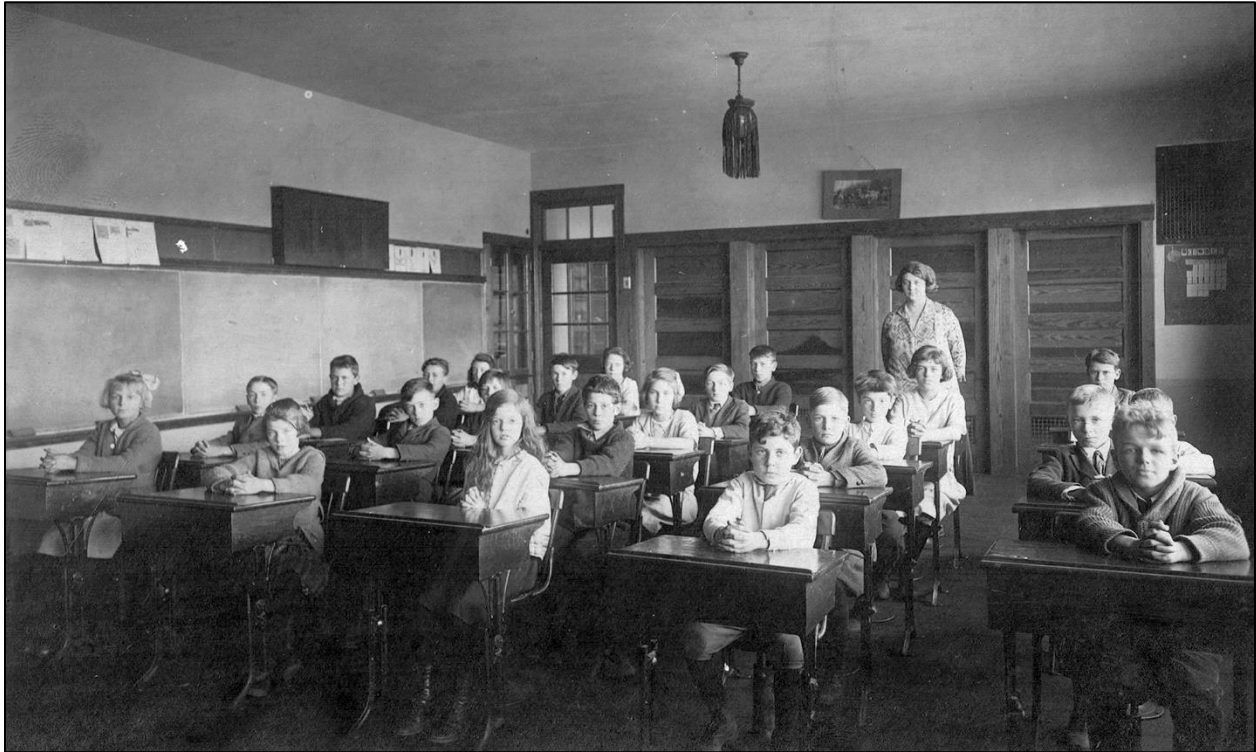
Figure 5: North classroom of Old Stone School in 1923 with grades 4,5, and 6 (Courtesy Newington Historical Society)

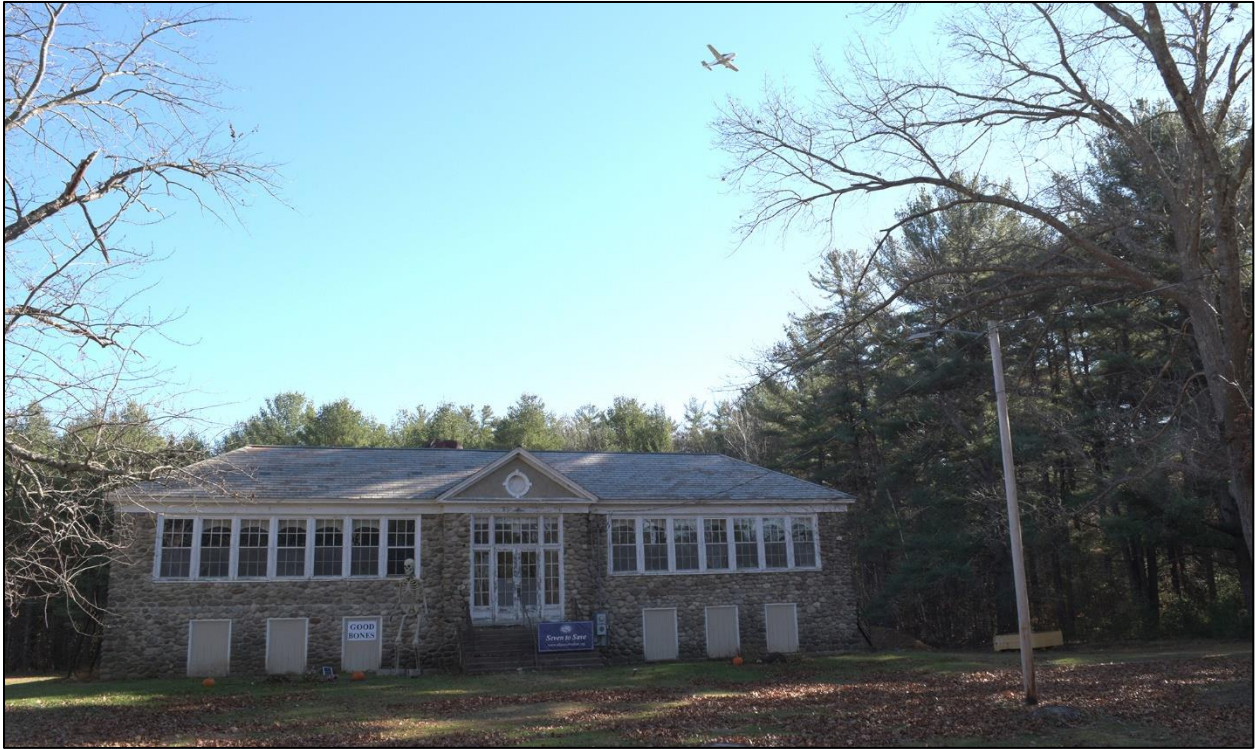
Figure 12: Old Stone School, photographed from Nimble Hill Road, facing east

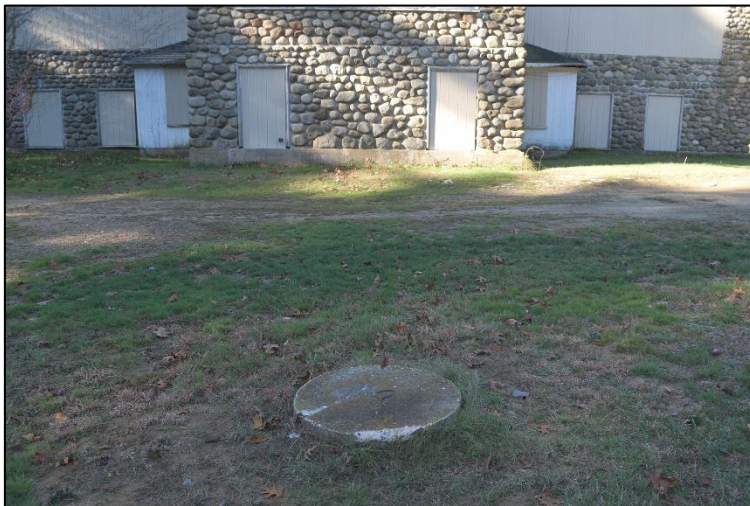
Figure 13: Location of Old Stone School septic tank to east of ell.

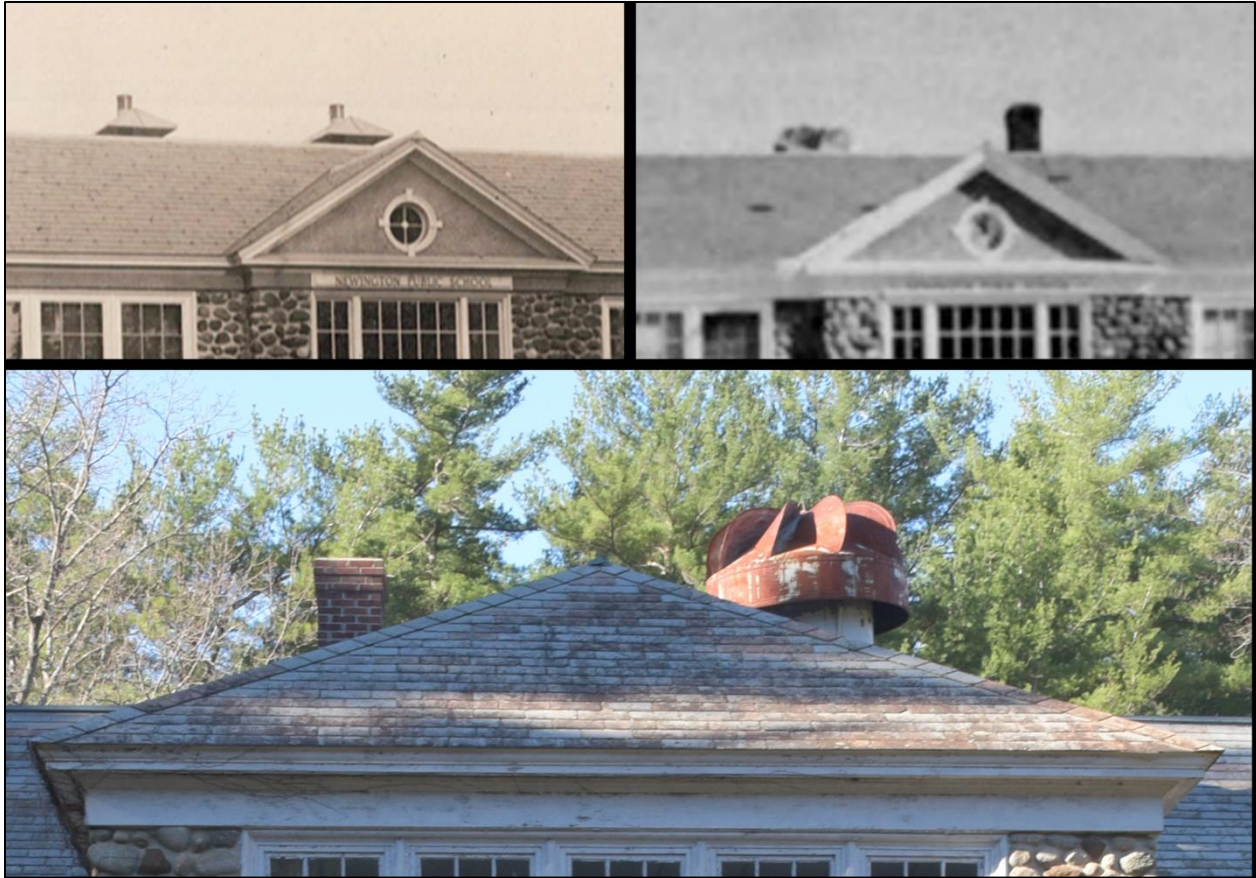
*Figure 16: Evolution of Stone School chimneys/ventilators showing original construction in 1921 from front of building (upper left), ca. 1948 from front (upper right) and present configuration from rear of building where they are more visible (bottom).*

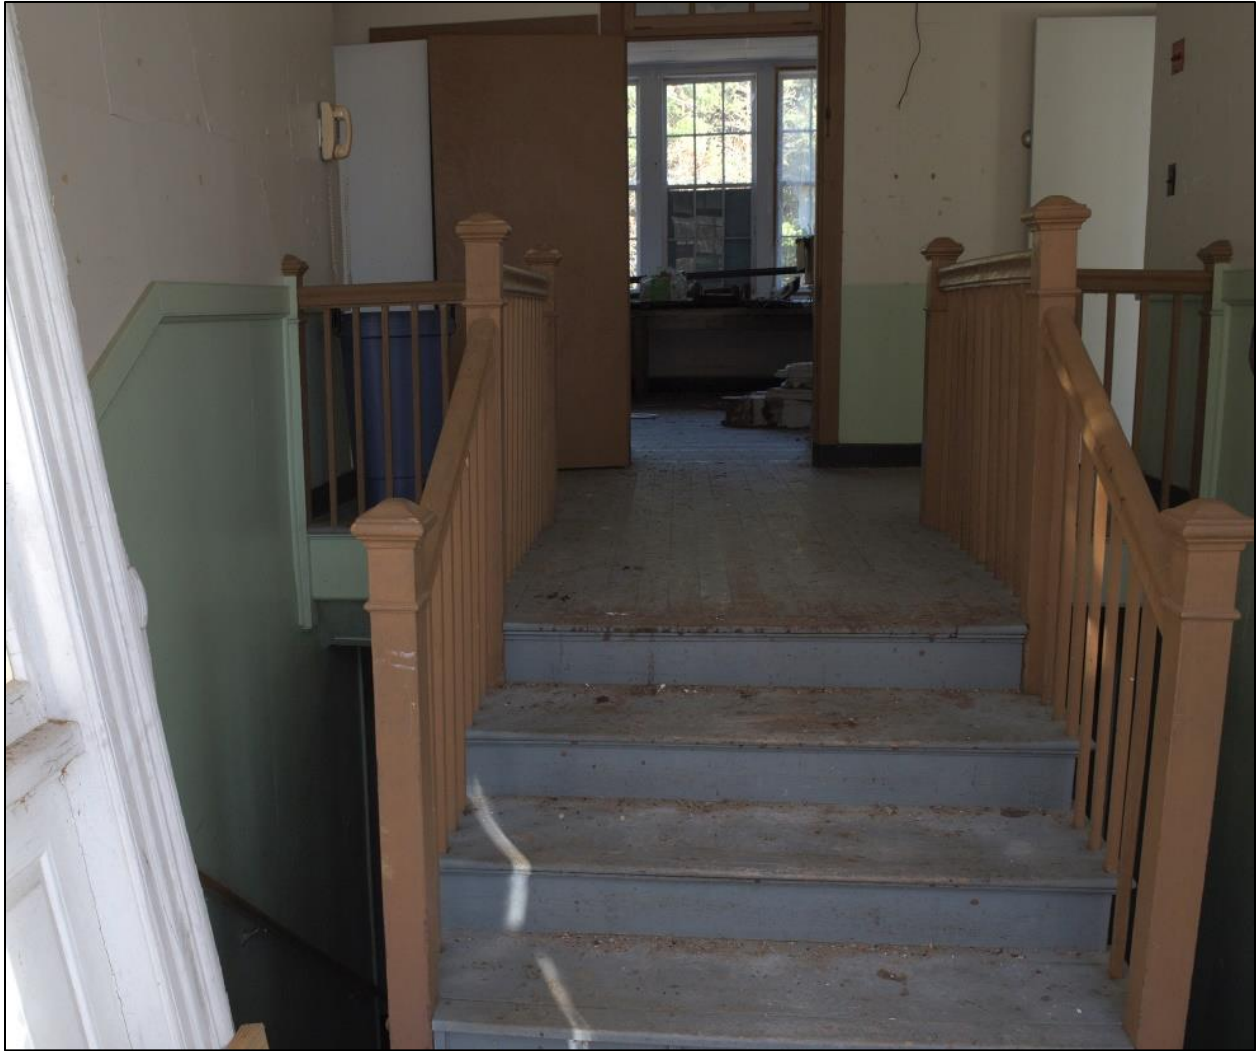
*Figure 21: Entry hall, facing east, toward ell.*

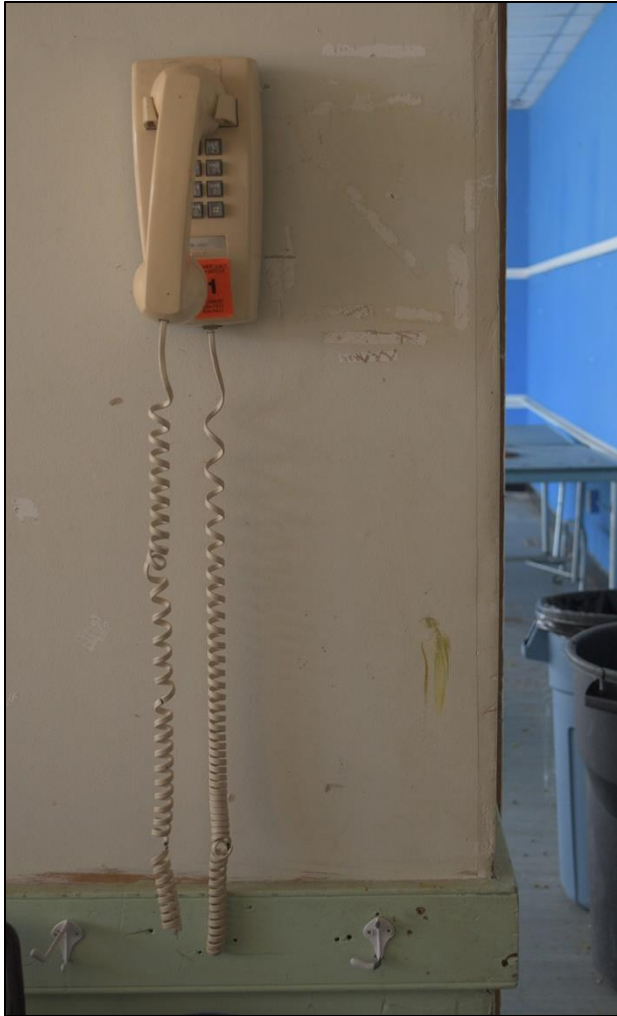
*Figure 22: Coat hooks at wainscot at upper landing*

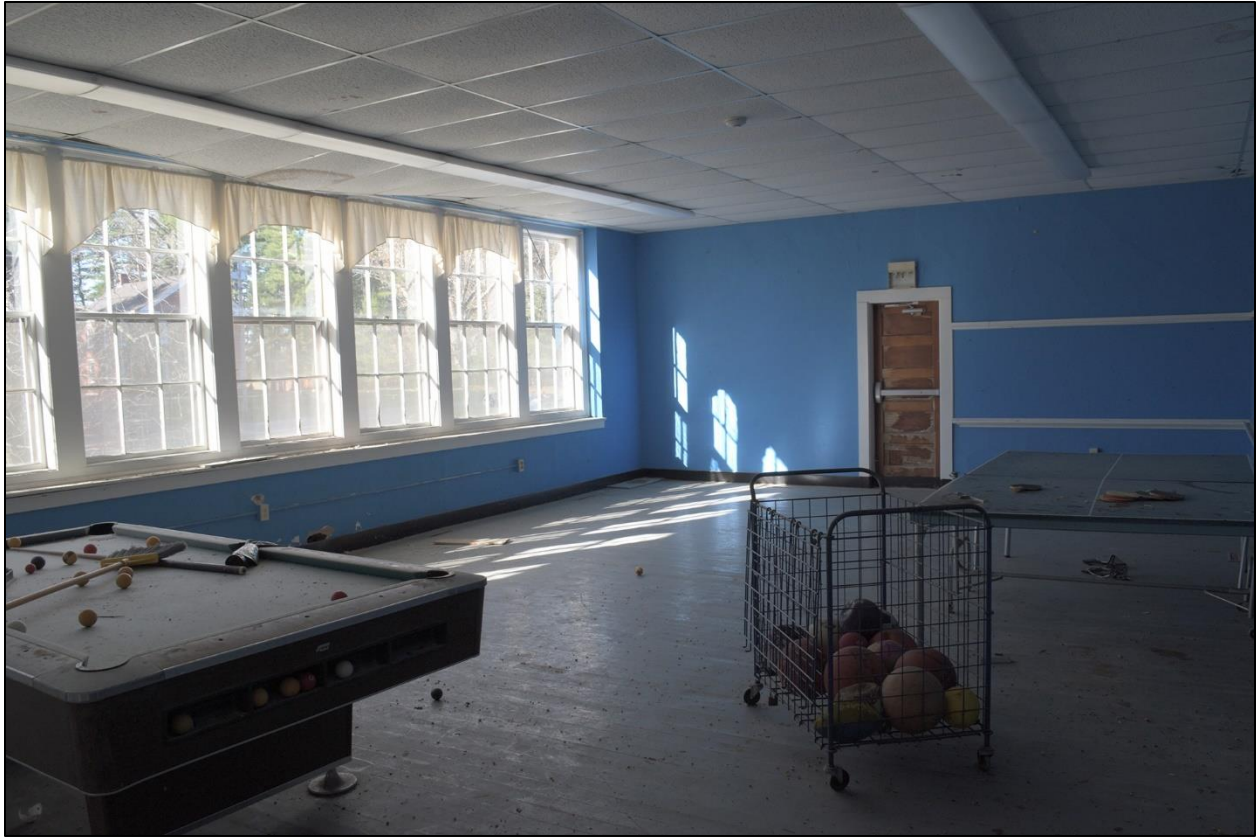
Figure 25: North classroom, facing northwest with 1944 fire escape door right of center

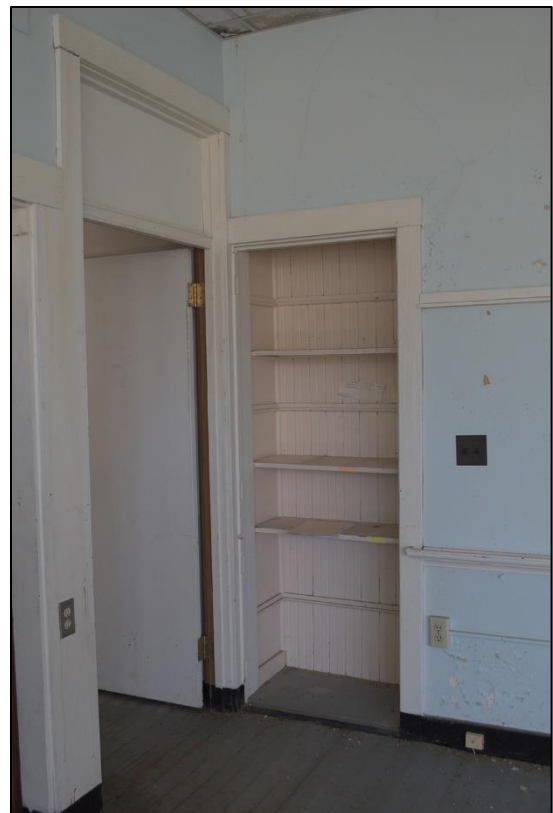
## Part II: Architectural Description with Character-Defining Features

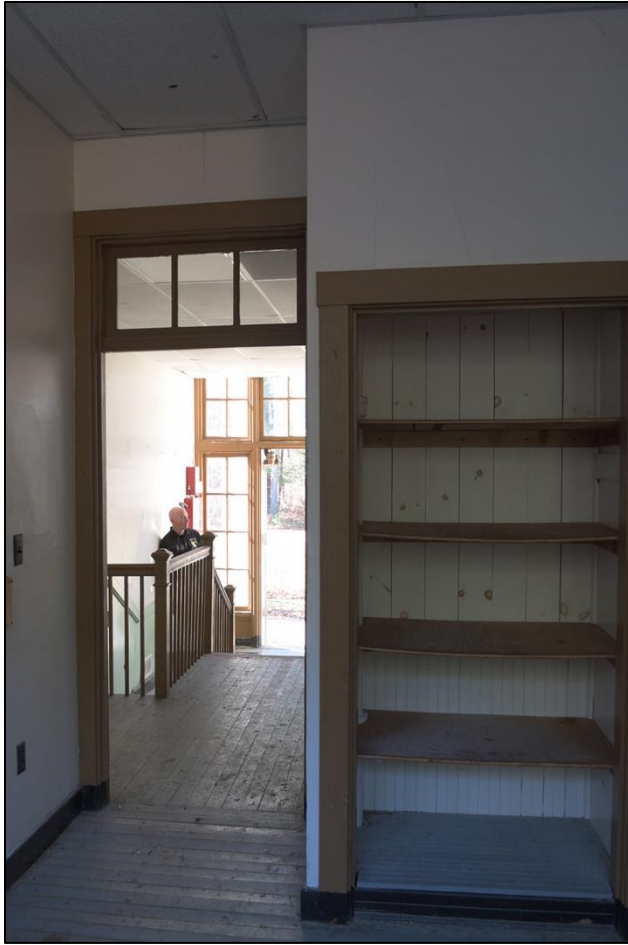
*Figure 30: View from ell classroom into entry hall (facing west). Note transom window and mid-20<sup>th</sup> century closet (right).*

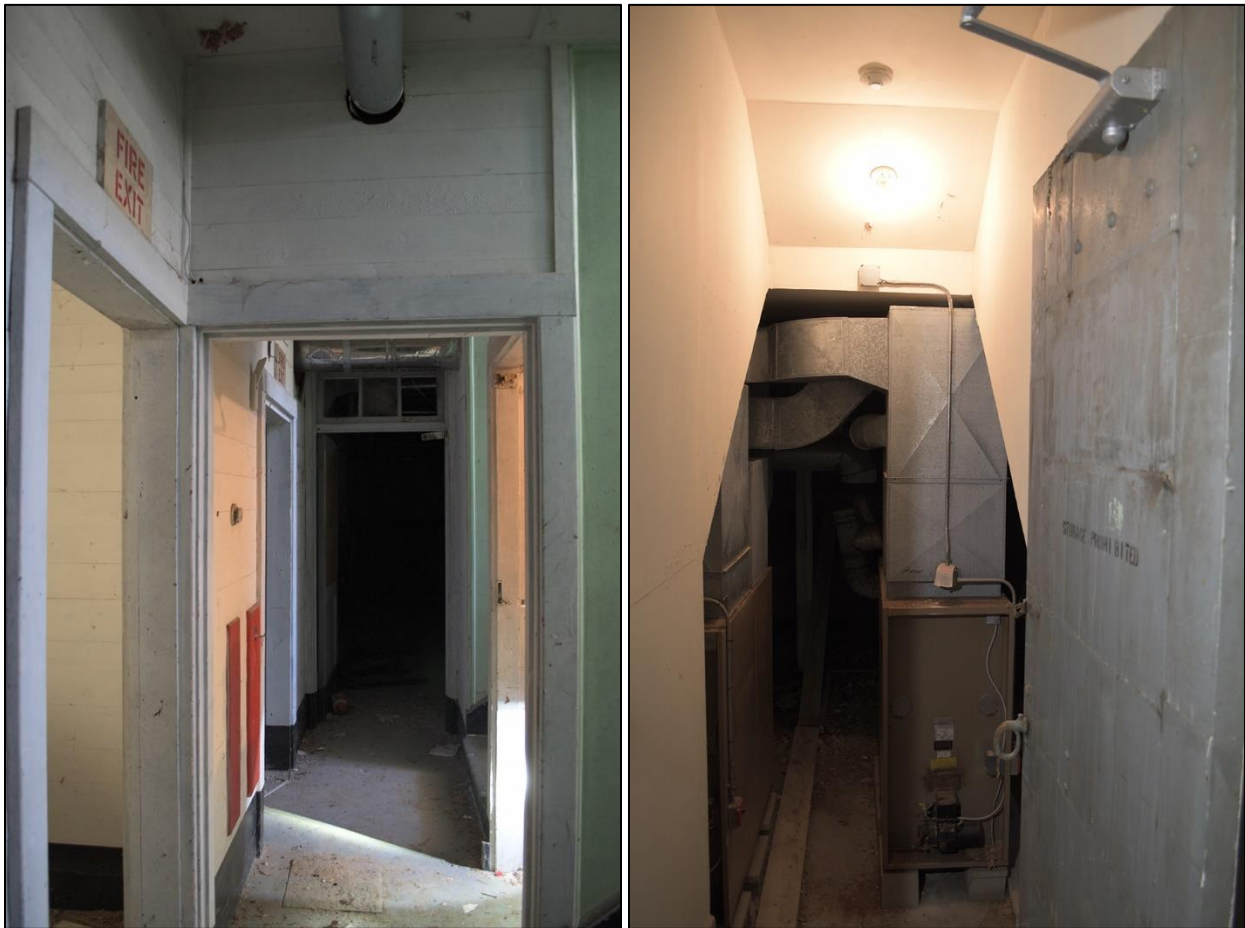
*Figures 33 & 34: Basement hallway, facing south from base of north set of basement stairs with door at left foreground leading to the north basement exit and girl's room, left mid-ground leading to south exit and boy's room, door at center leading into south storage/assembly room, and openings at right leading up to main hall and down to mechanical room (left). The image at the right shows the view down into the mechanical room from the hallway.*

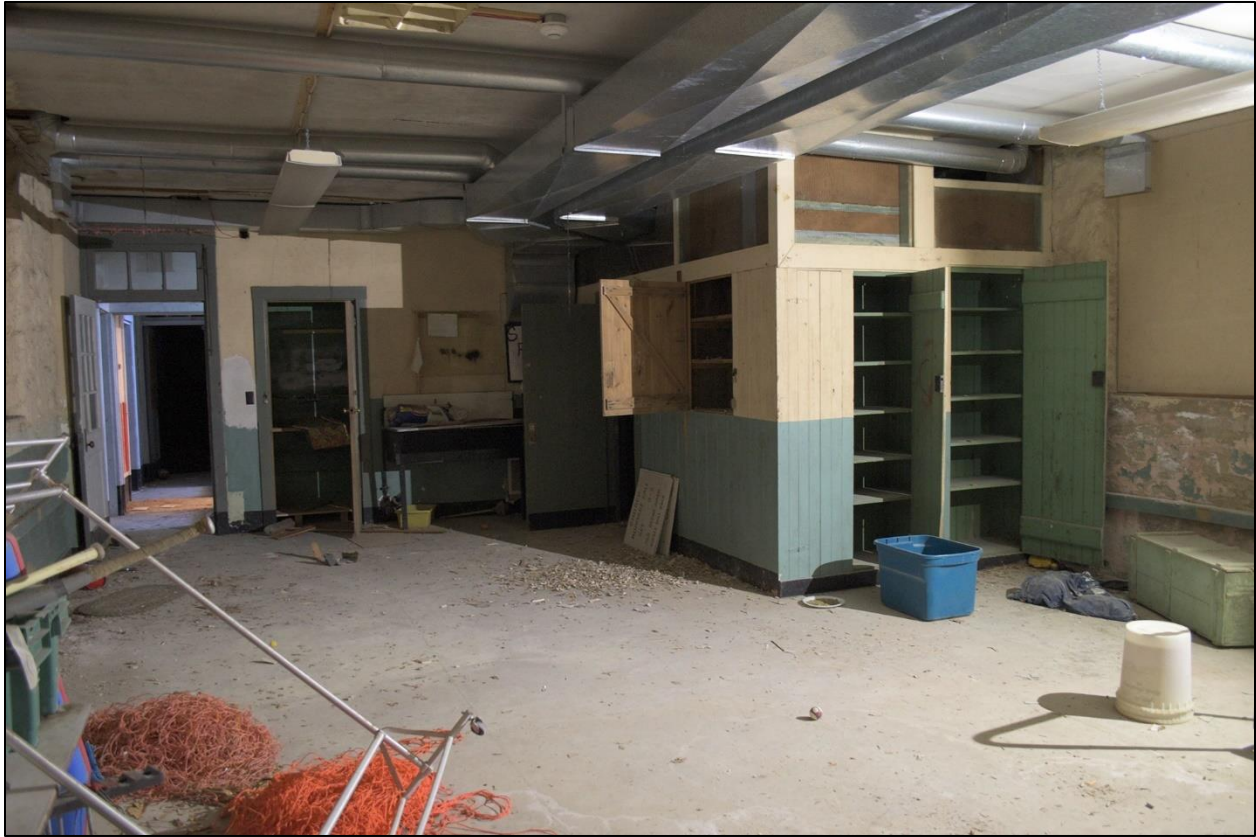
Figure 38: North storage room, facing southwest

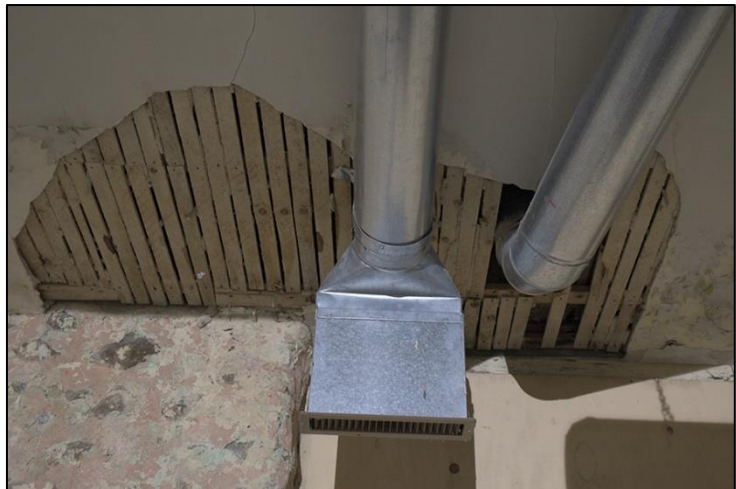
**Part II: Architectural Description with Character-Defining Features**

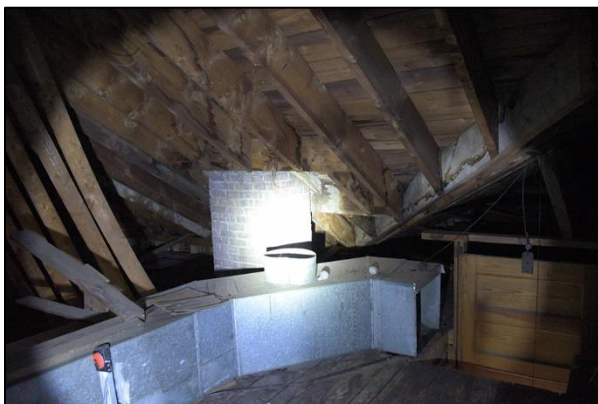
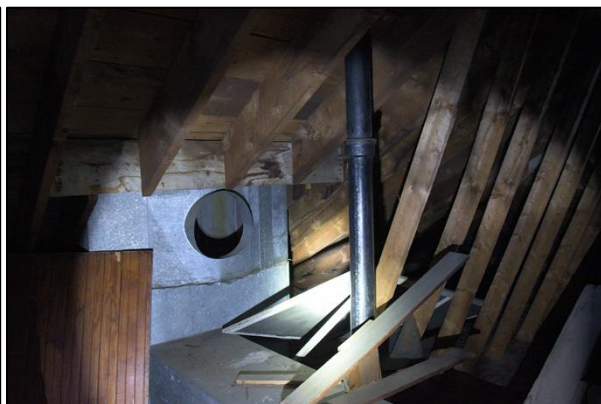
Figure 56: Historic brick chimney (south slope of ell) Figure 57: ca. 1948 vent that replaced original north chimney

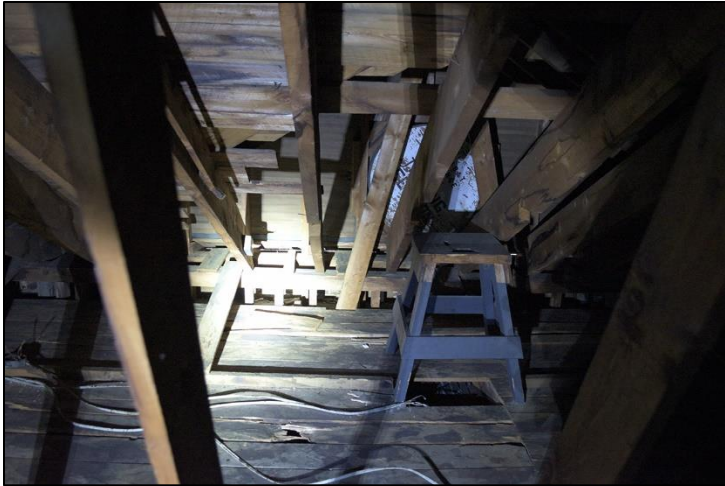
*Figure 59: West gable end, above primary entrance*

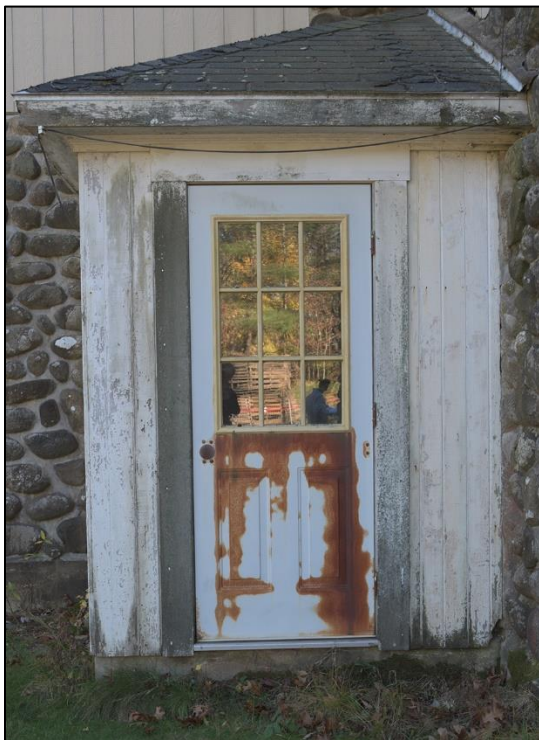
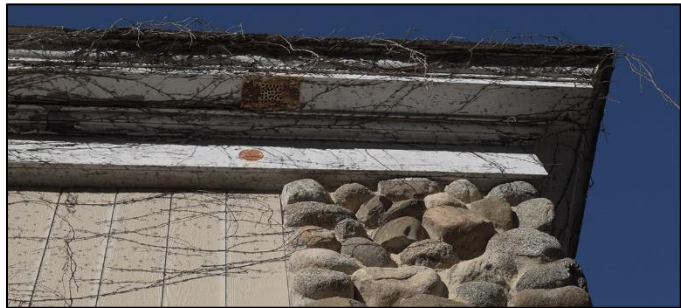
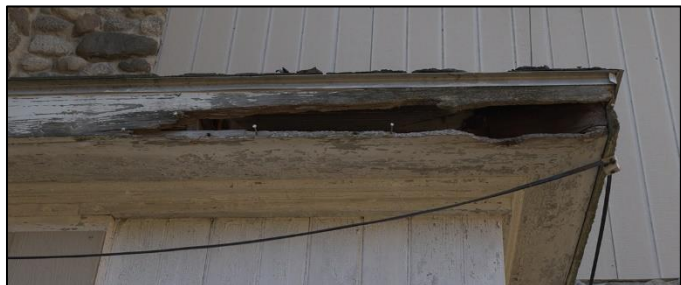
*Figures 60-62 (clockwise from left): North vestibule with degraded asphalt roof and rusted metal door; vegetative growth along fascia of main block (above), and rodent entry holes in fascia of north vestibule (below)*

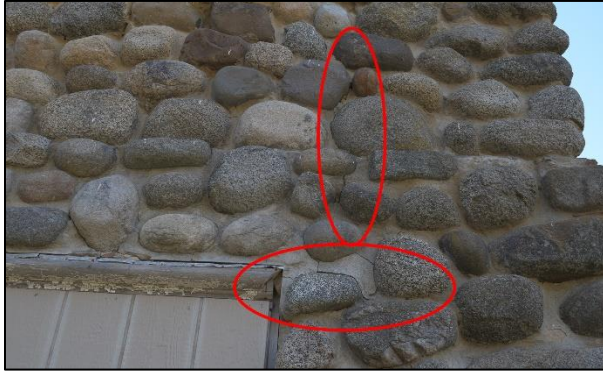
Figure 63: Cracks in cobblestone at east elevation

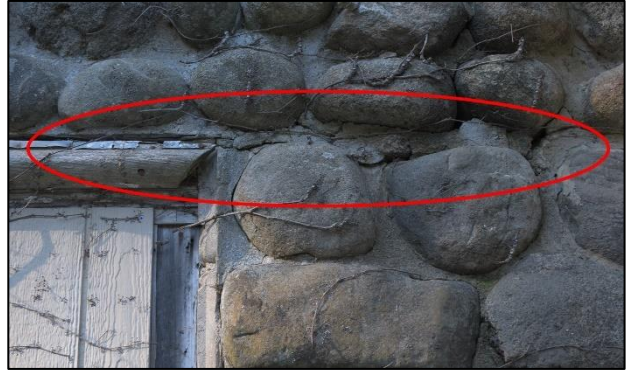
Figure 64: Cracks in cobblestone at west facade

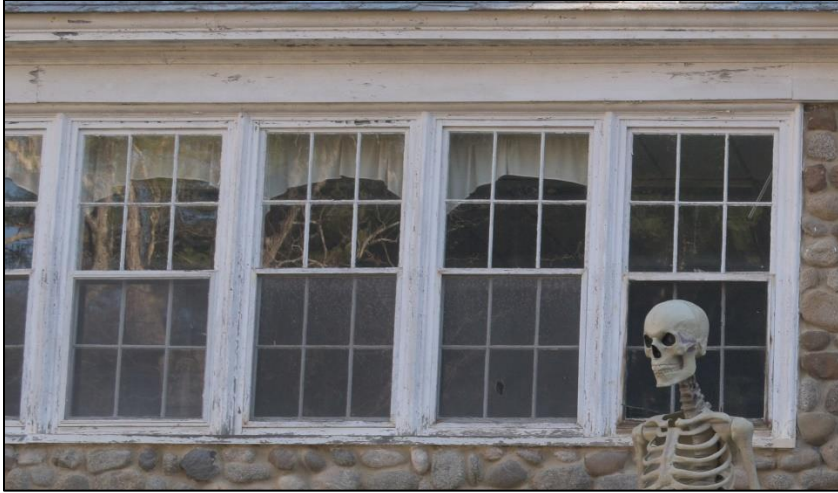
Figure 65: North classroom windows, facing east

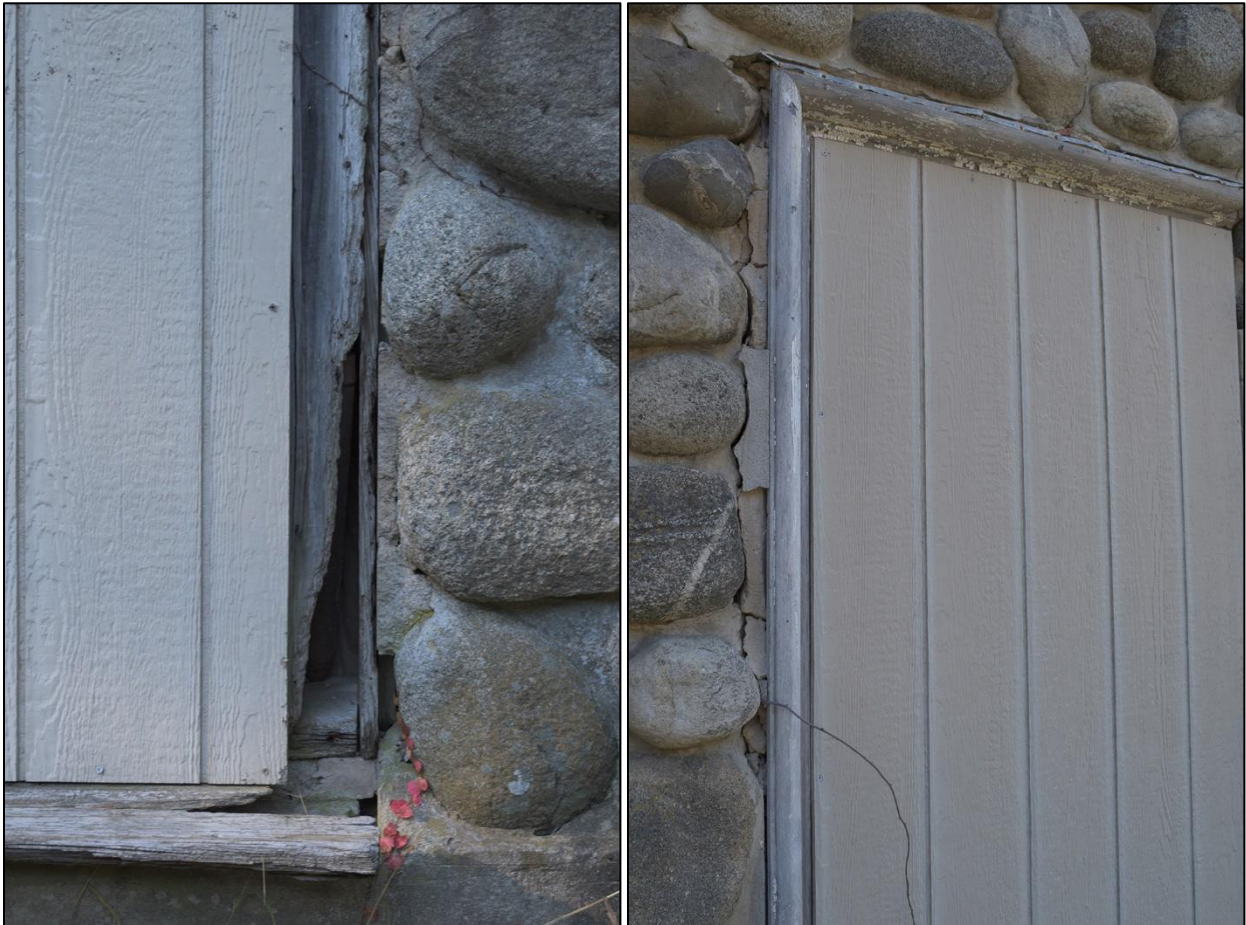
Figures 66 & 67: Details of lower level windows, showing damage to window casings (note large masonry crack at right image)

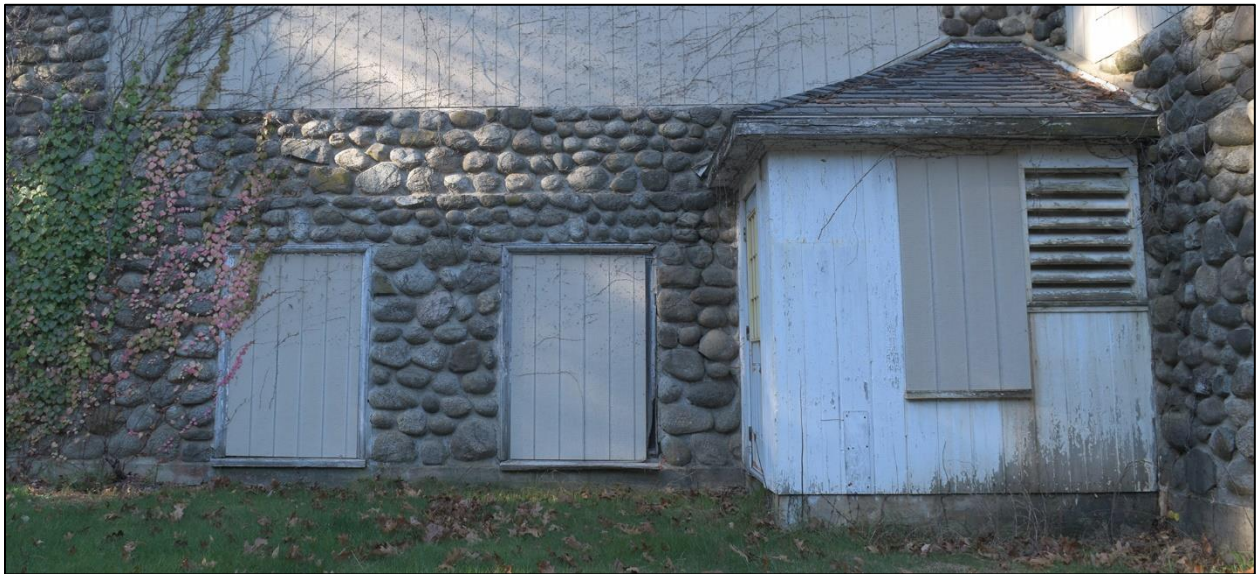
Figure 68: East elevation of south vestibule showing boarded window and louvered vent

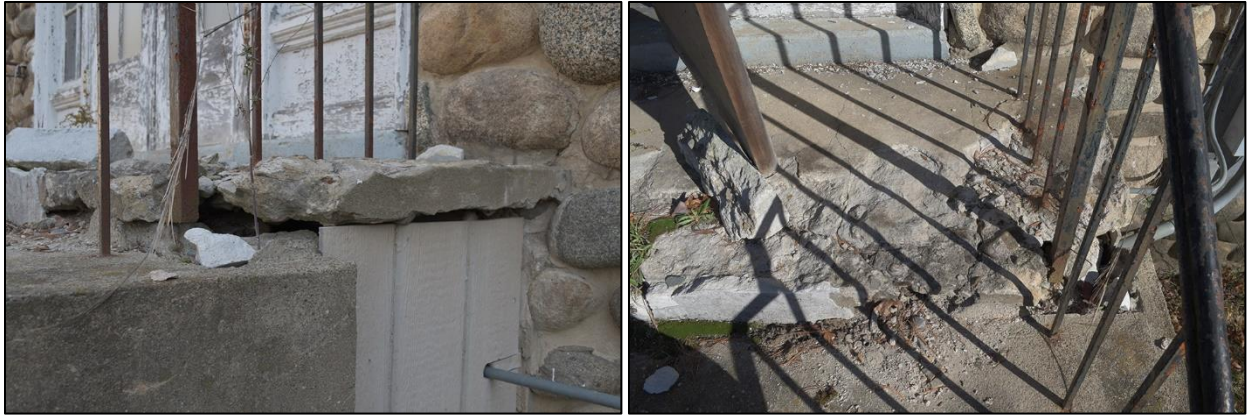
Figures 69 & 70: Damage to landing at south side of steps from the side (left) and above (right)

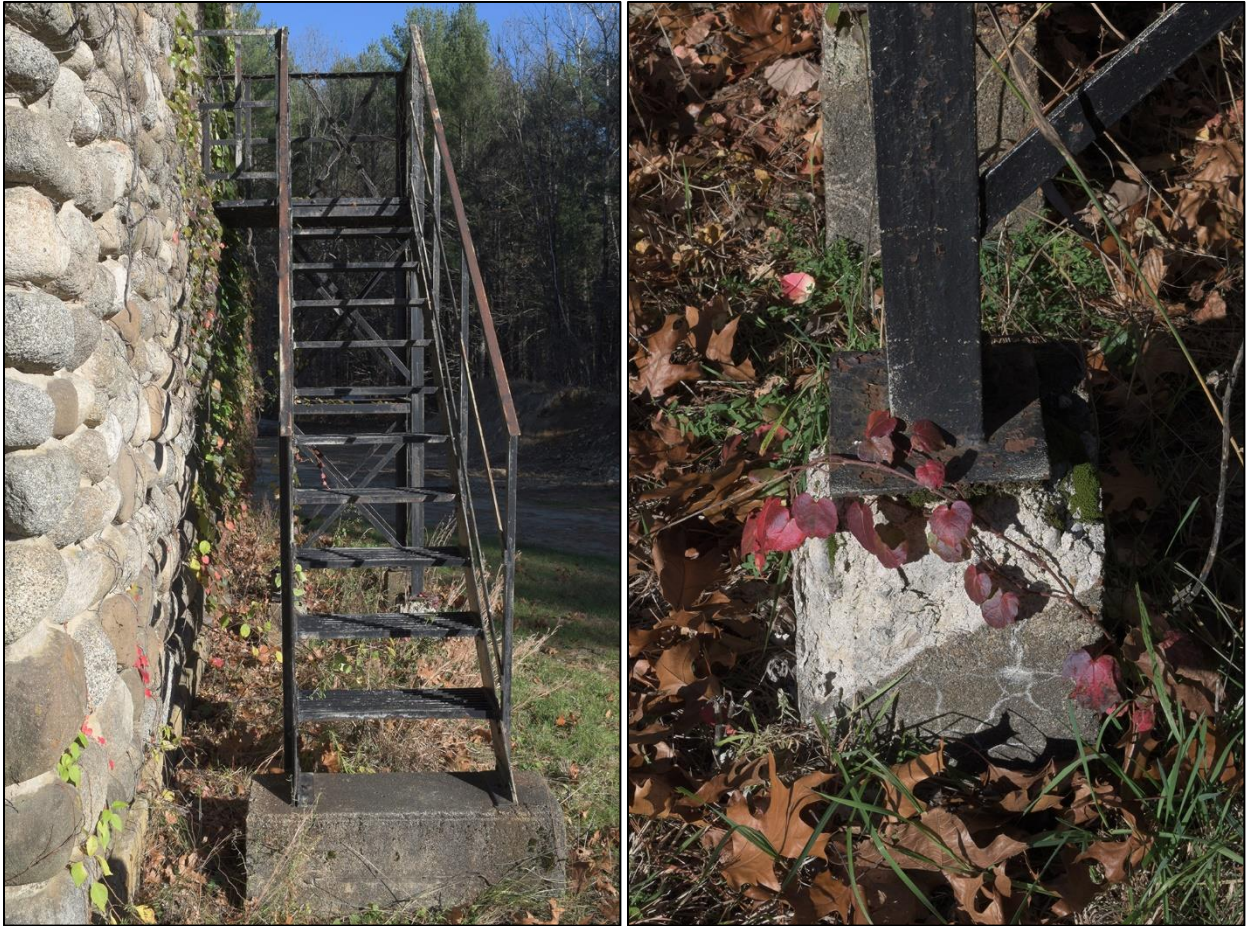
Figures 71 & 72: South fire escape stair configuration (left) and damage to concrete base (right)

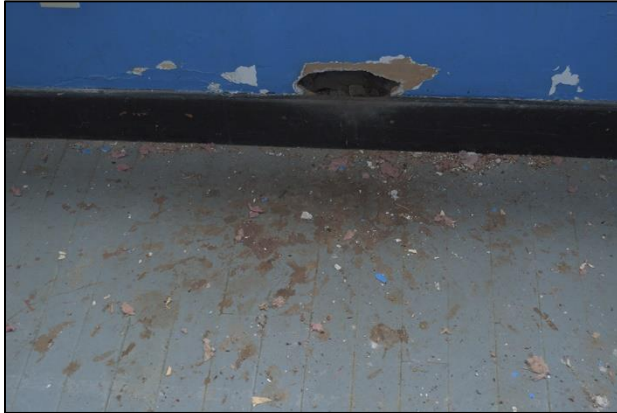
Figure 74: Rodent hole below north classroom windows

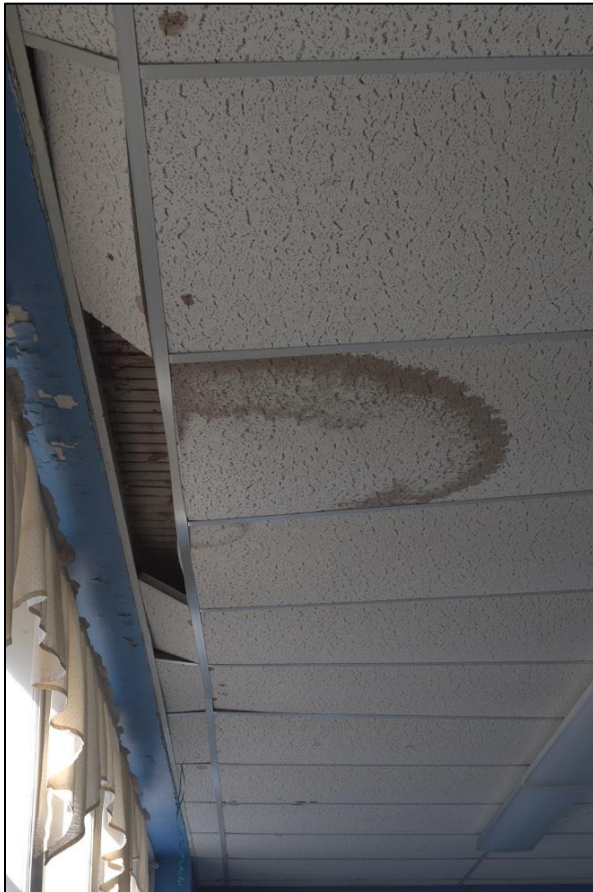
Figure 76: Water damage to ceiling above north classroom windows

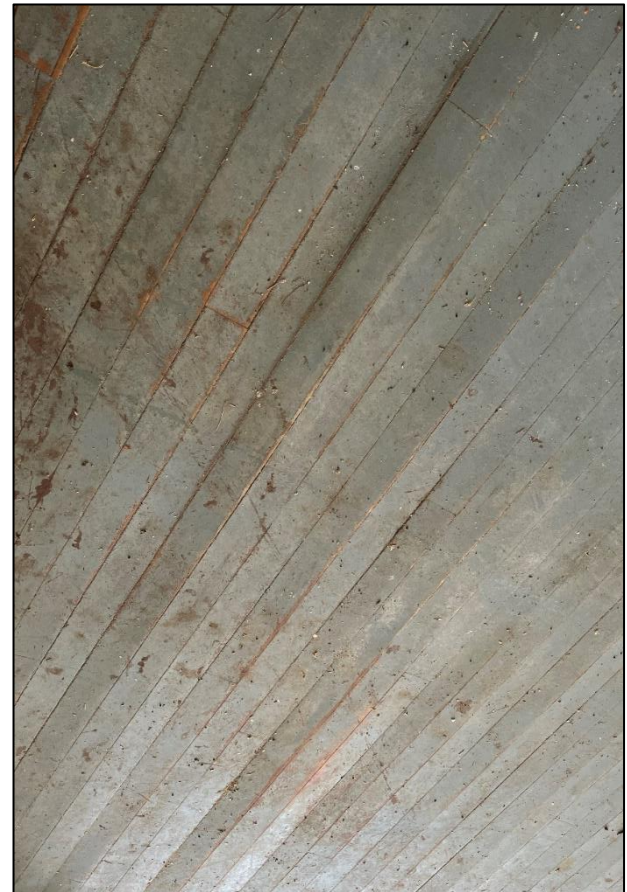
Figure 77: Damaged floor boards at northeast corner of south classroom

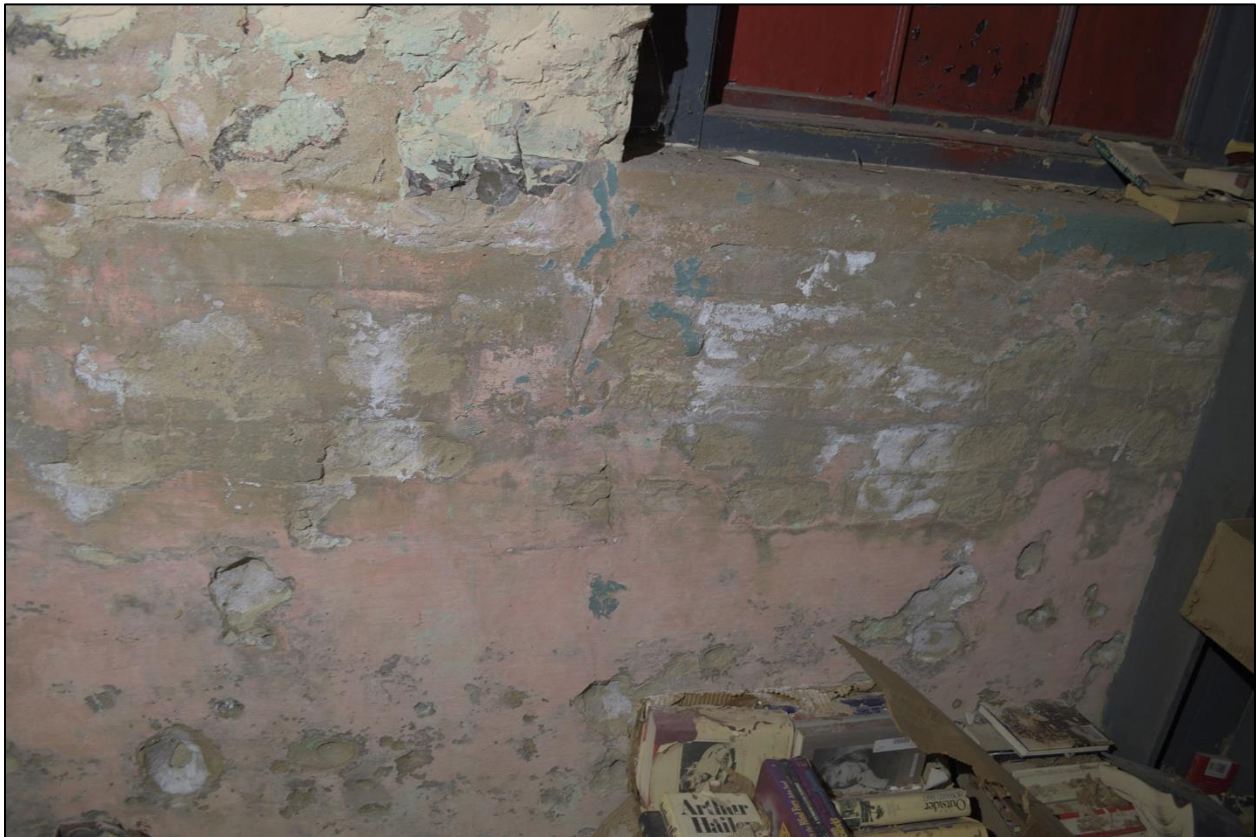
Figure 78: Efflorescence at west wall of north classroom (inside of built-in closet)

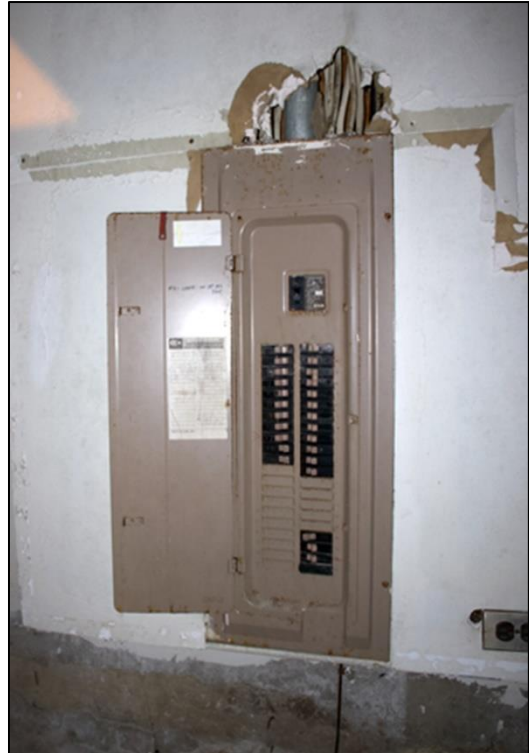
### **Part III: Existing Conditions Inspection**

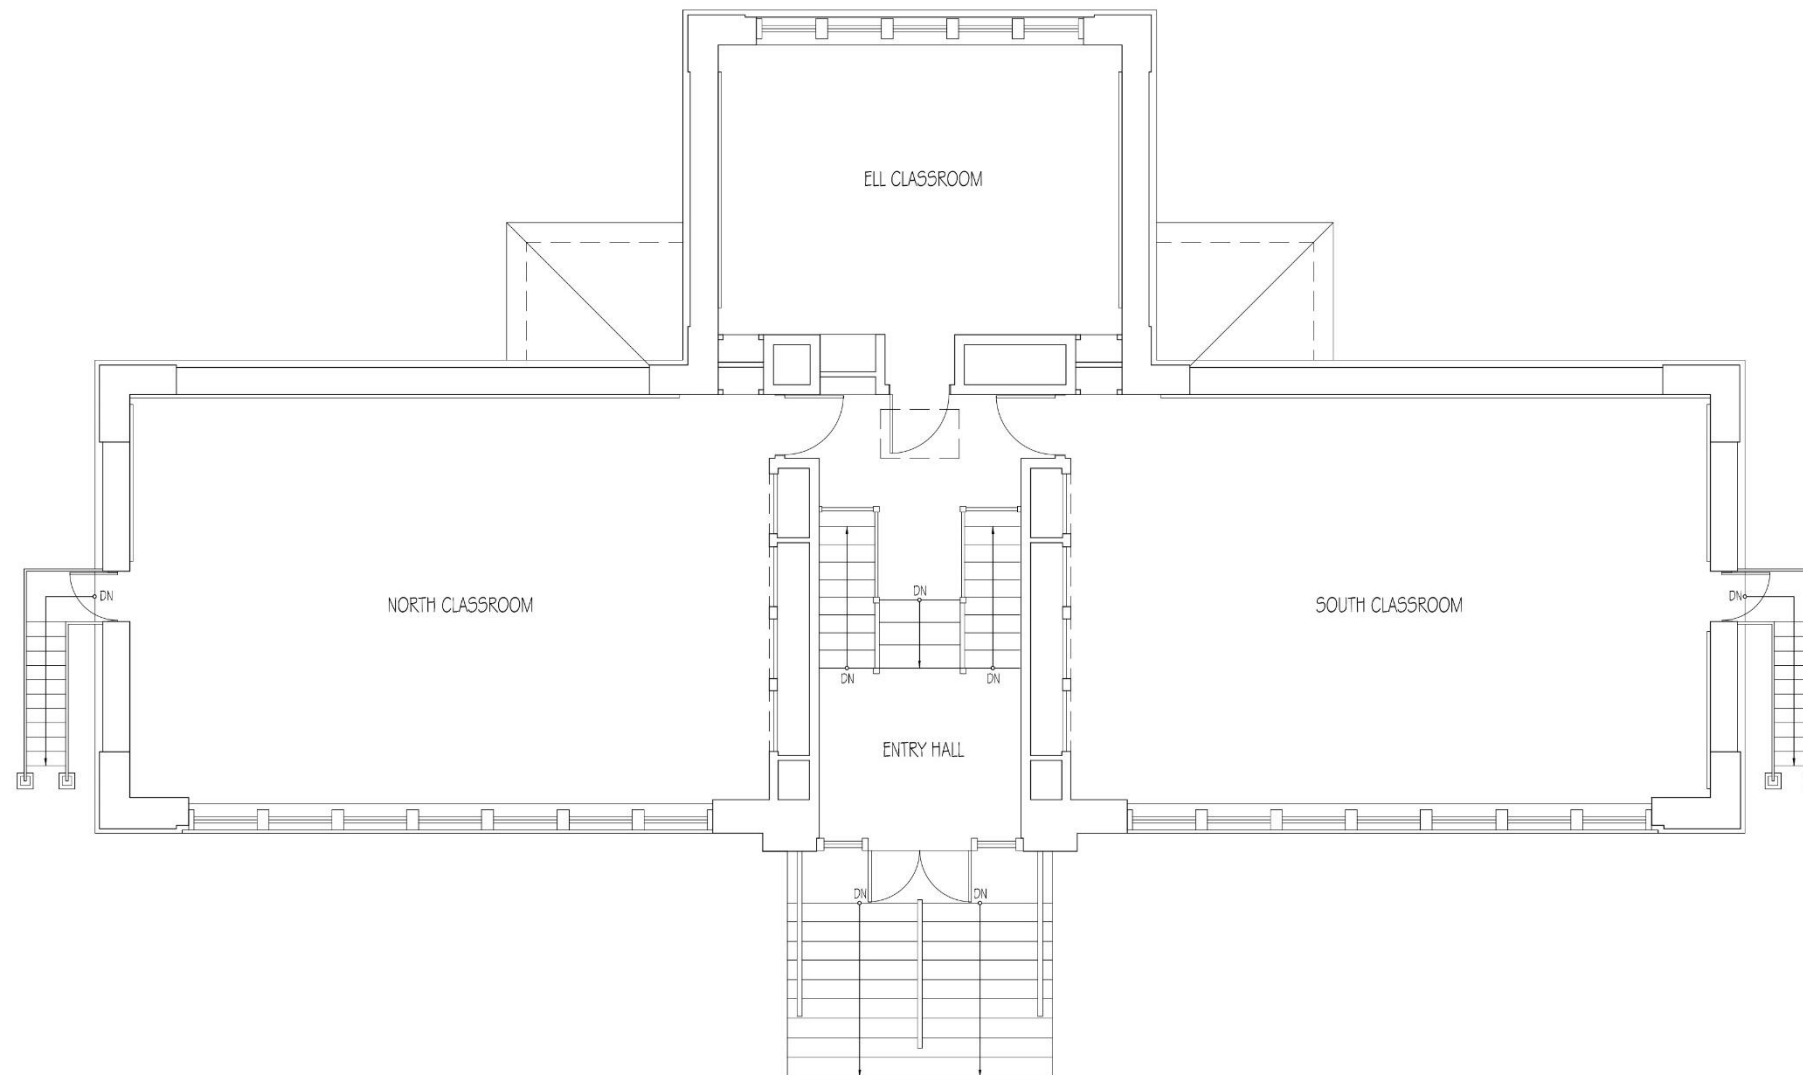
### **Part III: Existing Conditions Inspection**
