# **Historic Building Assessment for the Old Stone School**

**353 Nimble Hill Road, Newington, New Hampshire**

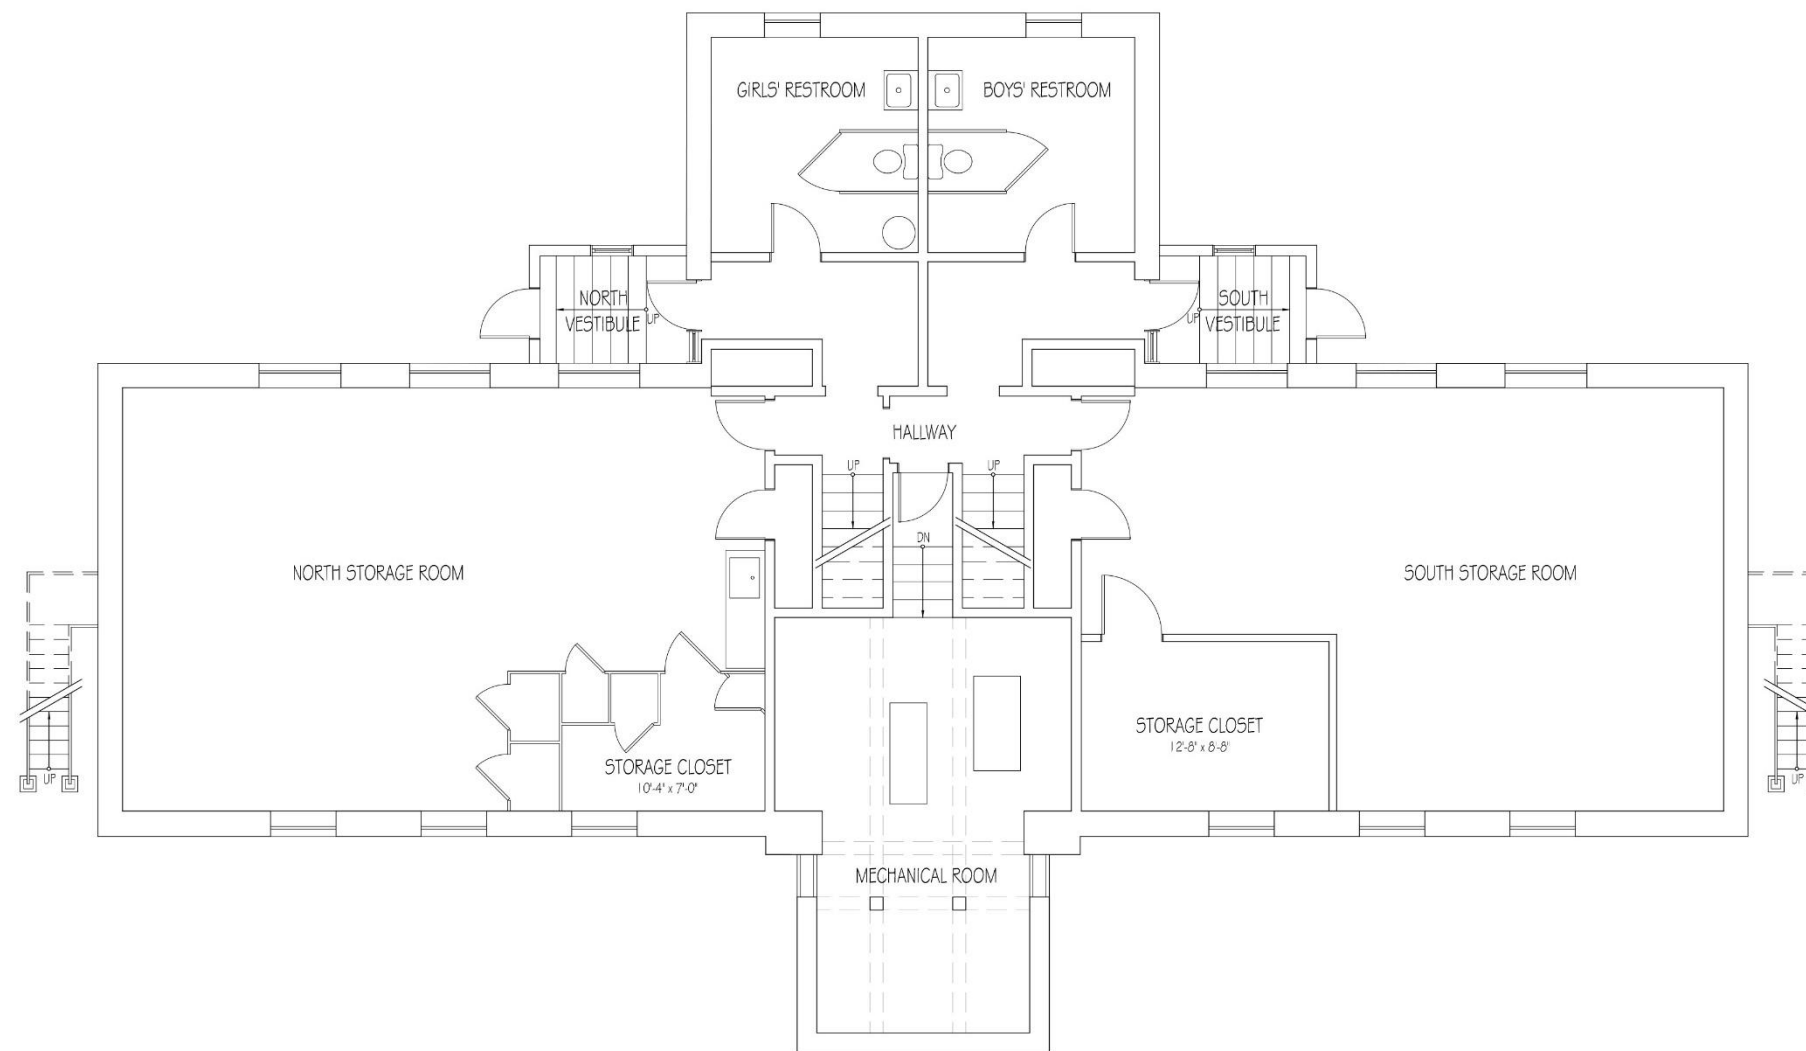
### **Part III: Existing Conditions Inspection**

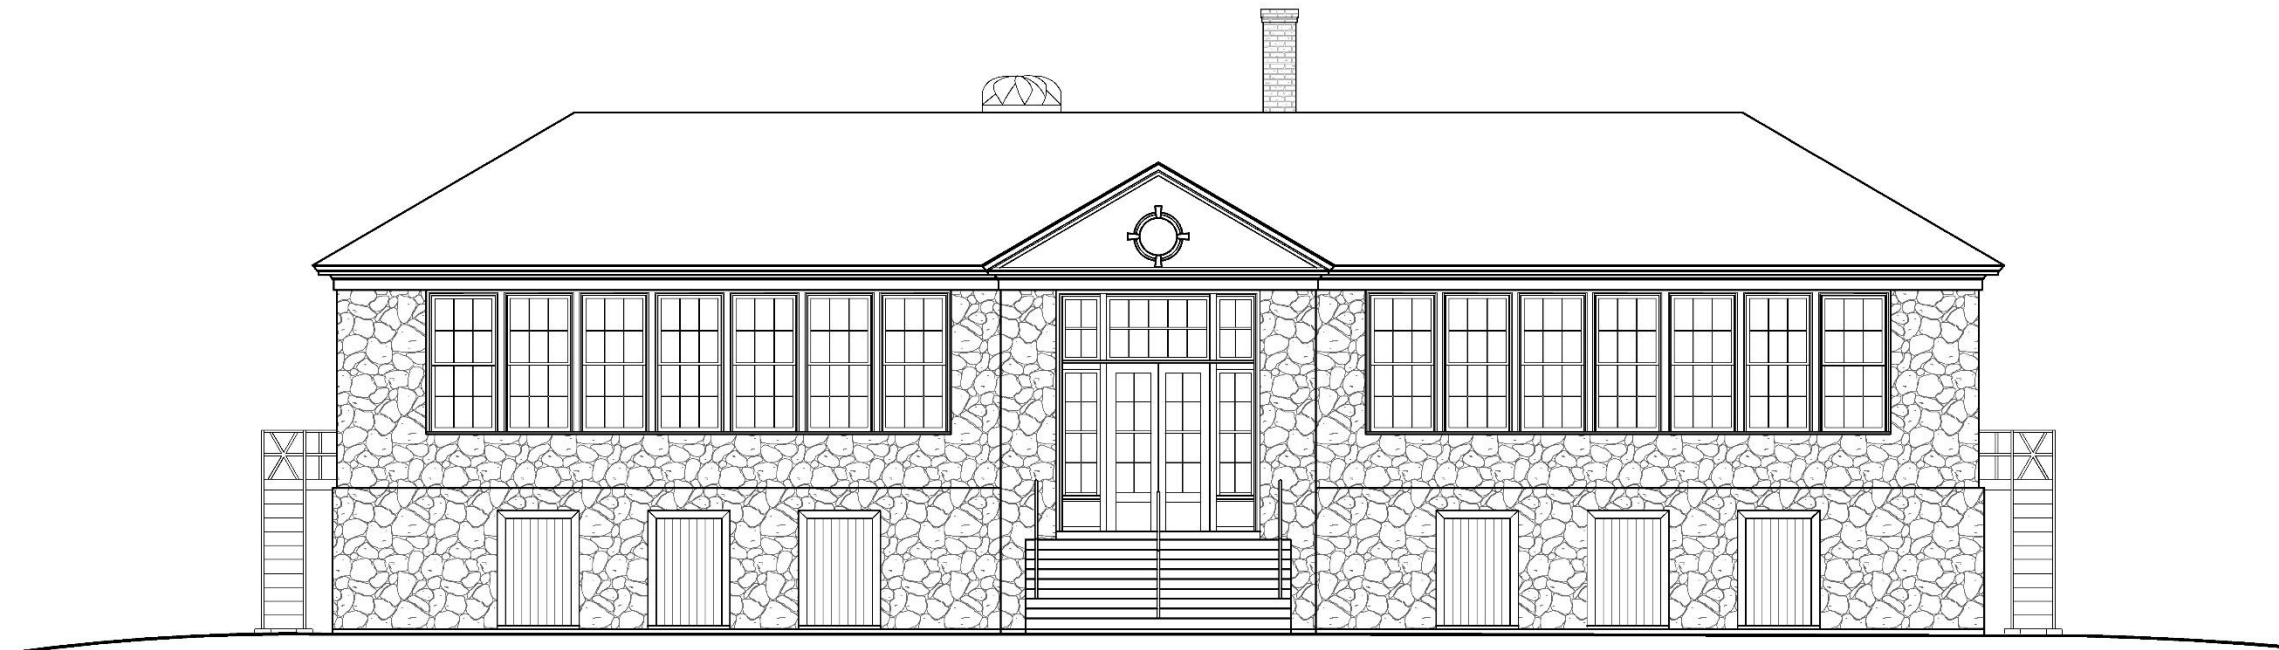
### **Part III: Existing Conditions Inspection**

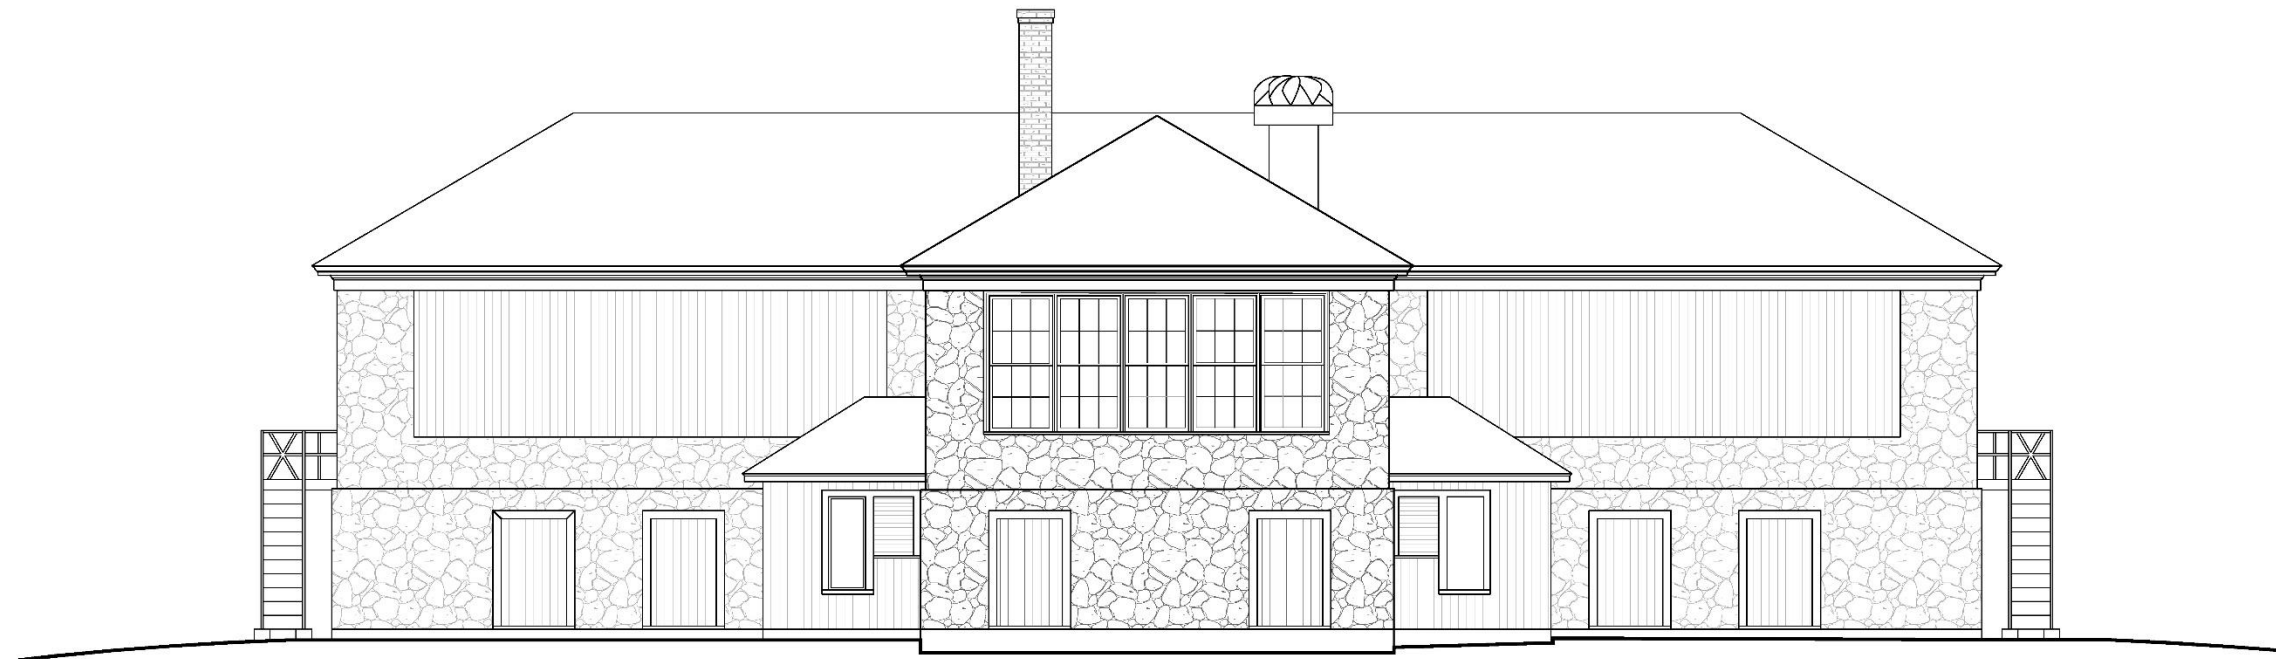
### **Part III: Existing Conditions Inspection**

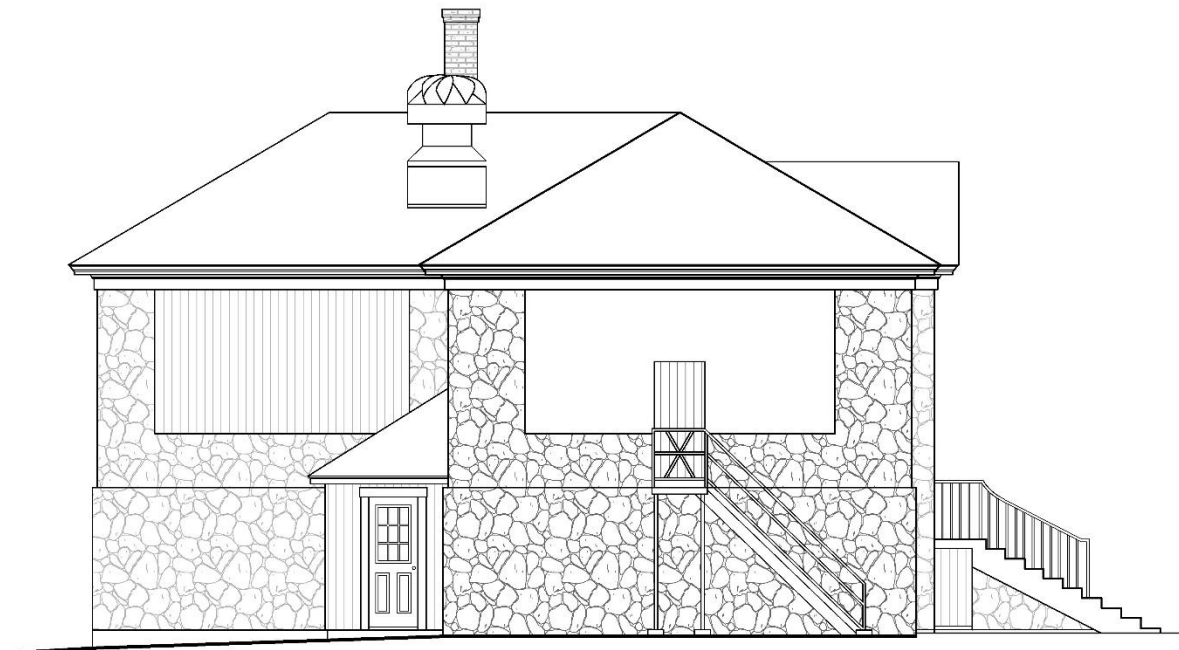
NORTH AND SOUTH ELEVATIONS  
OLD STONE SCHOOL  
MISIASZEK TURPIN PLLC - 2023
