# Newington Historic District Commission – DRAFT MINUTES

SITE WALK – Louis deRochemont house, a.k.a. the old Great Bay Training School property  
2061 Woodbury Avenue (Tax Map 27, Lot 2, 7.72 acres)

## Louis deRochemont House (1876)

### Historic District Commission Requests

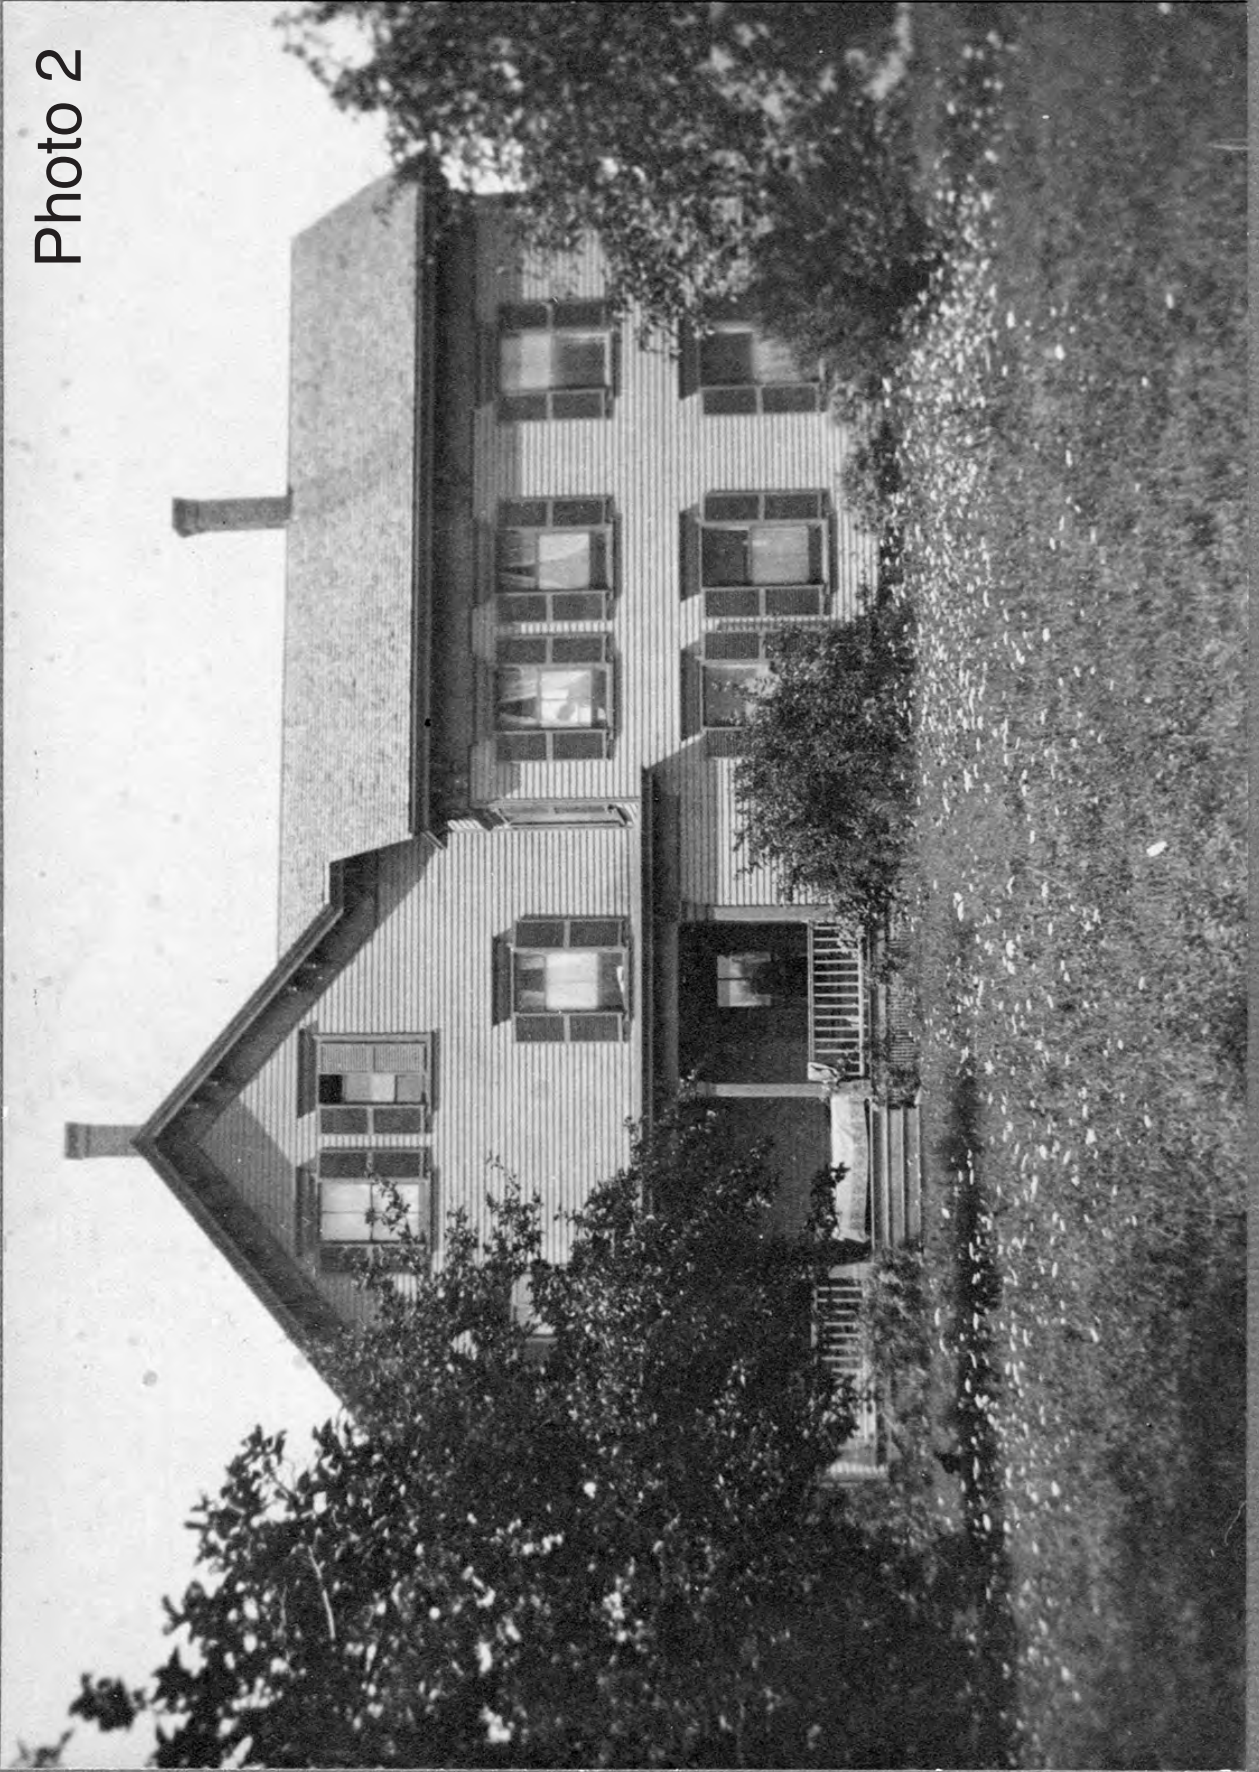
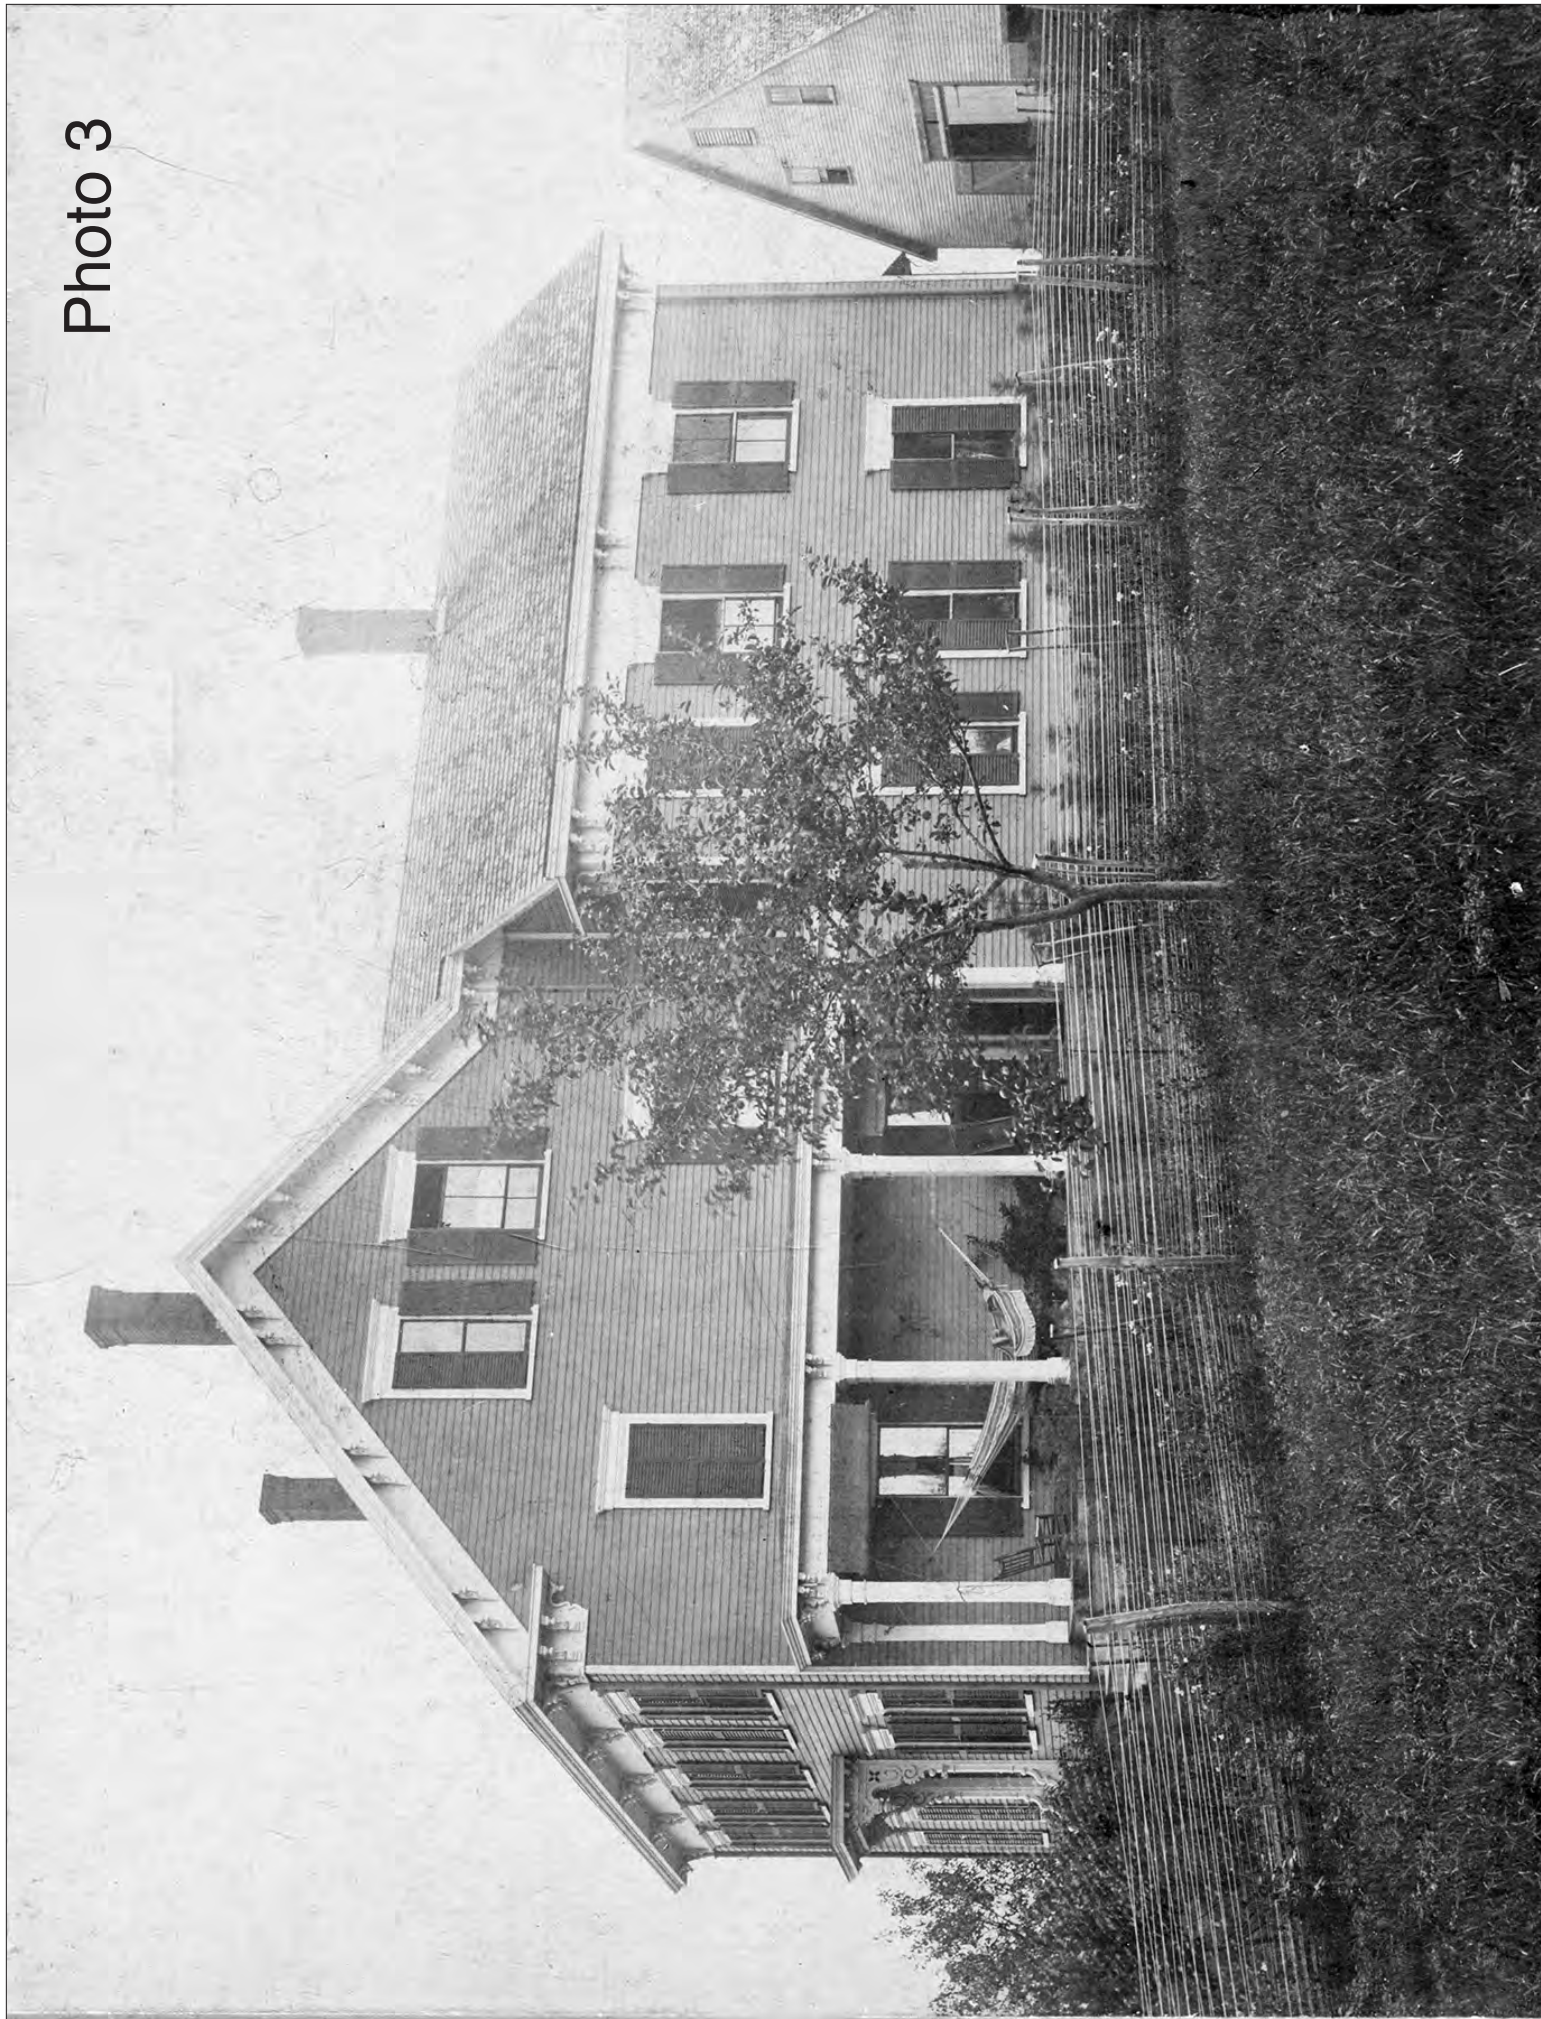
Photo #	Narrative with Requests in Bold Format
1, 2, & 3	<p>Newington Historical Society photos show the location of barns behind the farmhouse. The original chimneys in these photos no longer exist.</p> <p><b>We would like to retrieve as many foundation stones as still exist underground in the locations of the barns. It is possible that when the buildings were moved or demolished that the foundations were filled in and left in place. The stones in these foundations would likely have been dry-laid so they do not have mortar, paint, or lime wash as the farmhouse stones do. Someone from the HDC would like to be present when the contractor is trying to locate these old foundations.</b></p>
4	<p>Schematic of the buildings and their current locations (May 2018 Individual Inventory Form).</p> <p><b>Only the farmhouse has a stone foundation.</b></p>

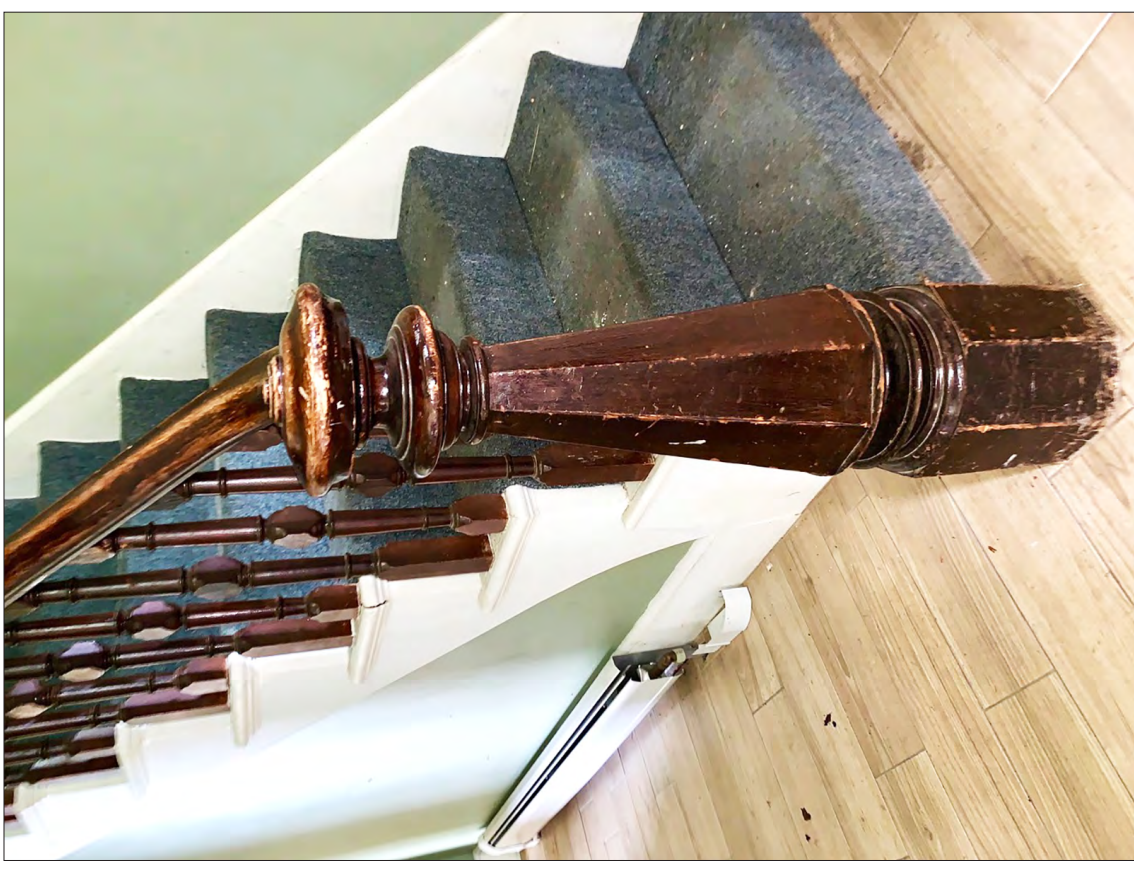
Photo 12a

12a 12b	<p>Photo of the original newel post, which its unique and faceted design.</p> <p><b>We would like to save the newel post. It is OK if it comes away from the tenon in the bannister. The newel post can be removed by unfastening the screw accessible under the floor in the cellar (photo 12b). The bottom tenon of the newel post should not be cut.</b></p> <p><b>The hope is that the entire balustrade, bannister, and newel post could be used in the renovation of another building.</b></p>
13	<p>Photo of one of the 2 over 2 sash windows, which retain their historic window moldings, hardware, sash weights, ropes and pulleys. This historic design was recently preserved in the Beane Farm on Nimble Hill Road that was renovated in 2018-2019.</p> <p><b>We would like to preserve two of the windows in the best shape. The whole window unit, trim and all can be cut from the wall. They could be used in the renovation of another building or kept as an example of the early ingenuity in window function.</b></p>

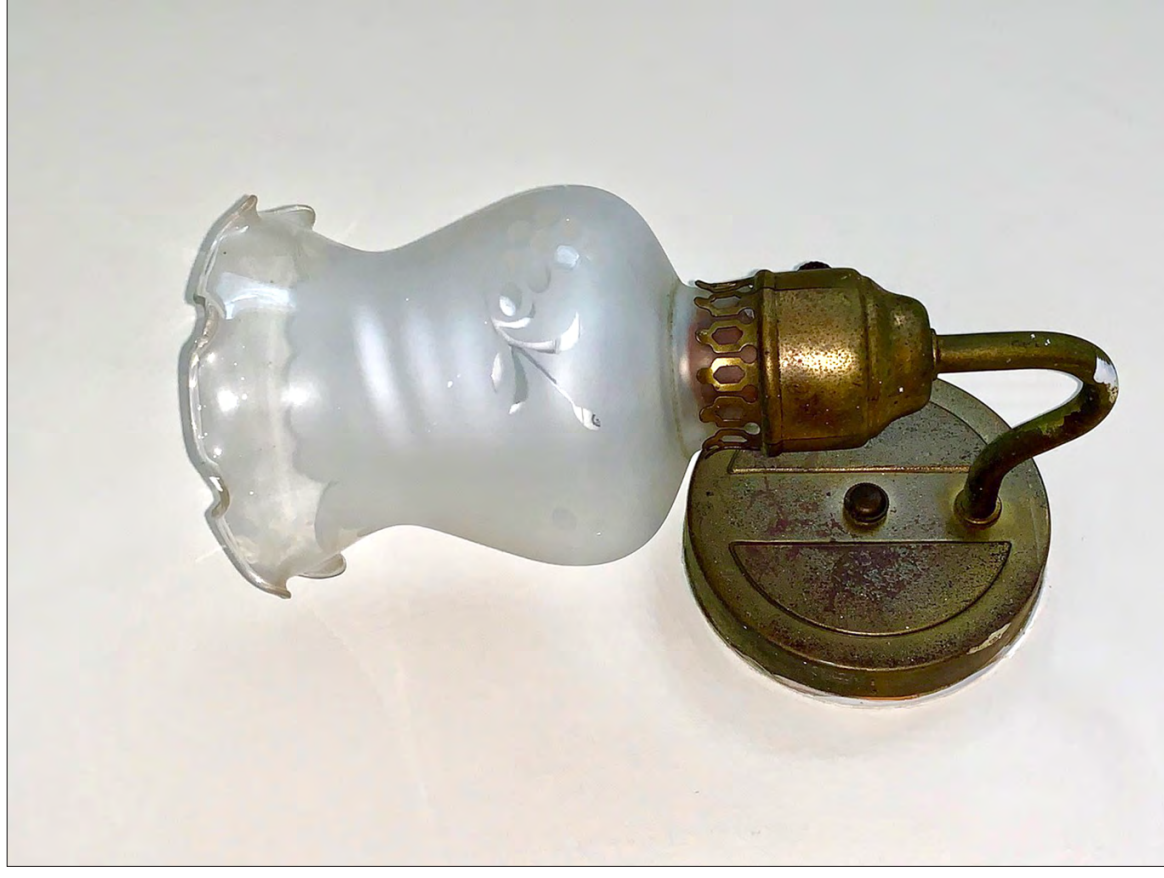
Photo 14

14	<p>Photo of one of the sconce lights.</p> <p><b>We would like to preserve the three sconces and shades in the upstairs hallway.</b></p>

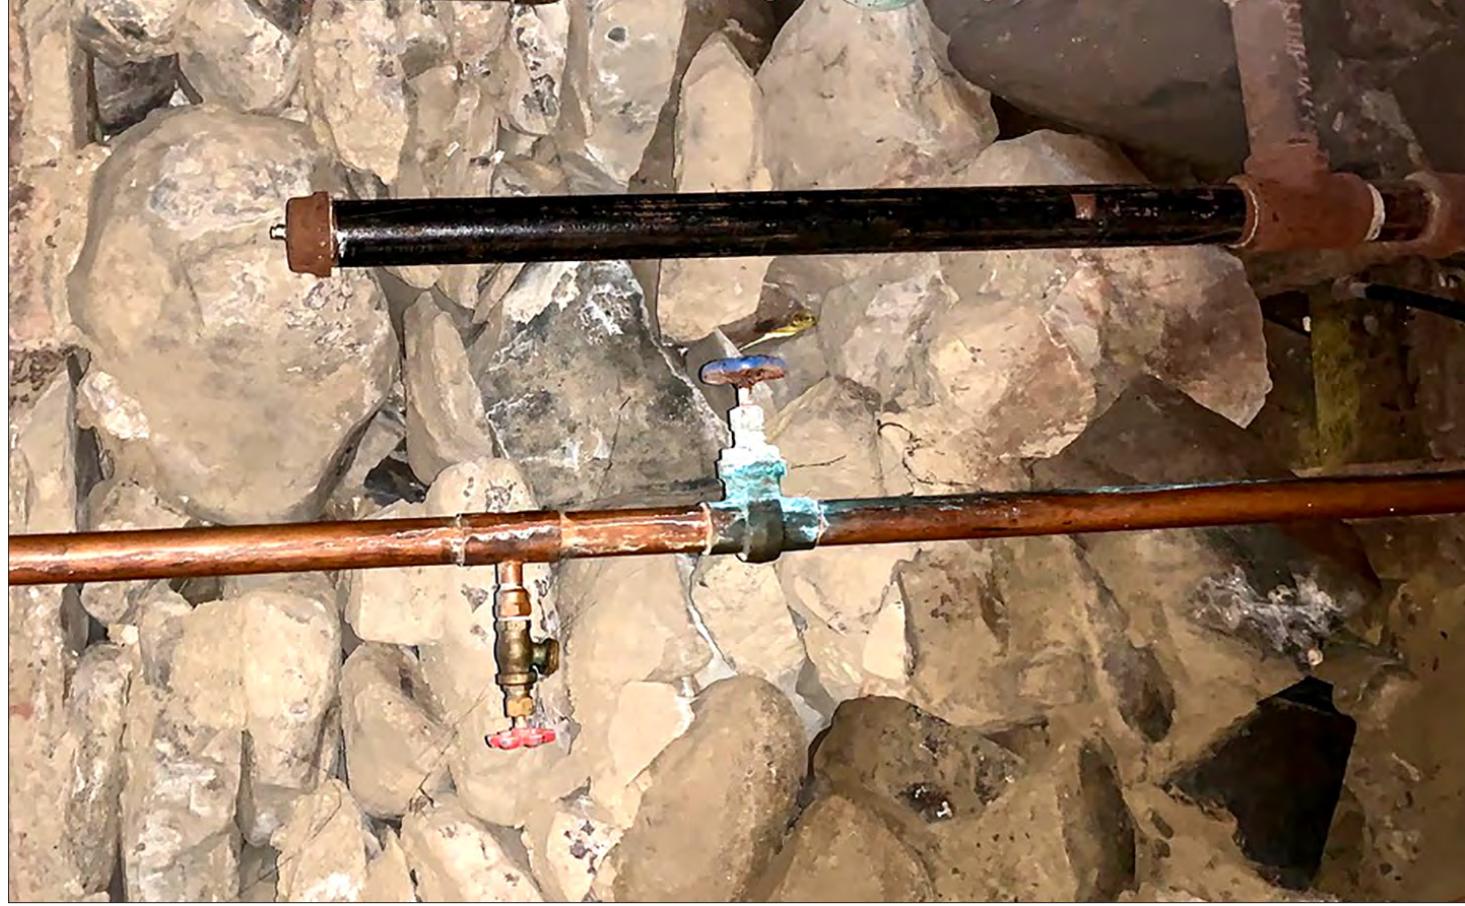
Photo 15

15 & 16	<p>Photo 15 taken in the cellar furnace room shows the backsides of the farmhouse foundation stones. These are all good-sized stones, many with a rounded shape that are perfect for stonewall restoration.</p> <p>Photo 16 shows another section of the foundation with mortar between the stones and what looks to be paint or lime wash on the surface of many stones.</p> <p>We have been emailing with a mason about reuse of the cellar foundation stones. He asked whether there appear to be any fibers in the white wash or lime mortar because that might indicate that the white material contains asbestos. The initial report indicates no asbestos around the stone, but that will be confirmed and certified after all the asbestos is removed from the building.</p> <p>We acknowledge that some stone may not be salvageable during demolition. Based on the age of the stone, some types of stone could crumble during removal. It may have good integrity when joined together, but during the demolition process there could be an issue.</p> <p>If no asbestos is present on the stones, the mason says the stones can either be wire brushed, which is very labor intensive, or if the layer is not too thick, he has built wall with lime coated stones and sandblasted afterwards using tarps to catch debris. For the current project we are only interested in salvaging and collecting the stones, how to remove the white material can be a future problem.</p> <p><b>We would like to preserve as many of the foundation stones are possible. We are not interested in the bricks. It is OK if the wall sections fall apart, the shape of the foundation wall does not need to be preserved. The stonemason will need to separate the stones by size anyway before a new wall can be laid.</b></p> <p><b>We would like to be present when the work is underway to gauge any difficulties. Our hope is that the excavator/contractor that you use can transport the stones to a laydown area in the historic district where the stones will be stockpiled for future use.</b></p>

Our hope is that the excavator/contractor that you use can transport the stones to a laydown area in the historic district where the stones will be stockpiled for future use.

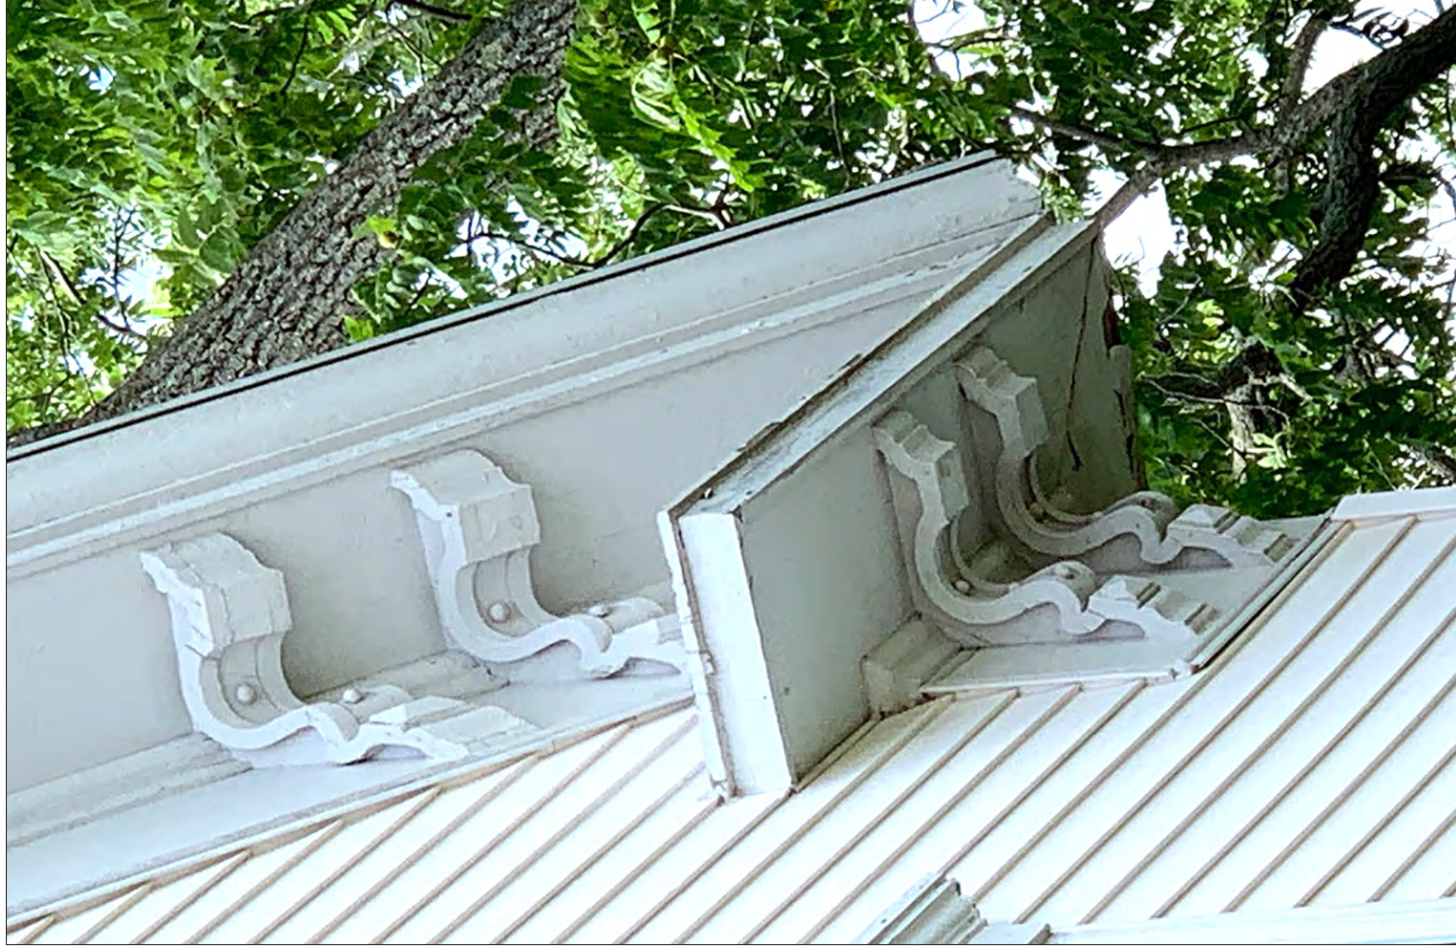
Photo 17

17	<p>Photo of the decorative Italianate detailing of paired brackets under both the eaves and the cornice returns on the gable end.</p> <p><b>We would like to preserve two of the brackets that are in the best shape and have the clearest details. These will likely not be reused in a building restoration project but could be used as templates to create replicate brackets in the future.</b></p>
18	<p>Photo of beech tree by Woodbury Avenue. This property has some great mature landscaping features, such as this outstanding beech tree.</p>

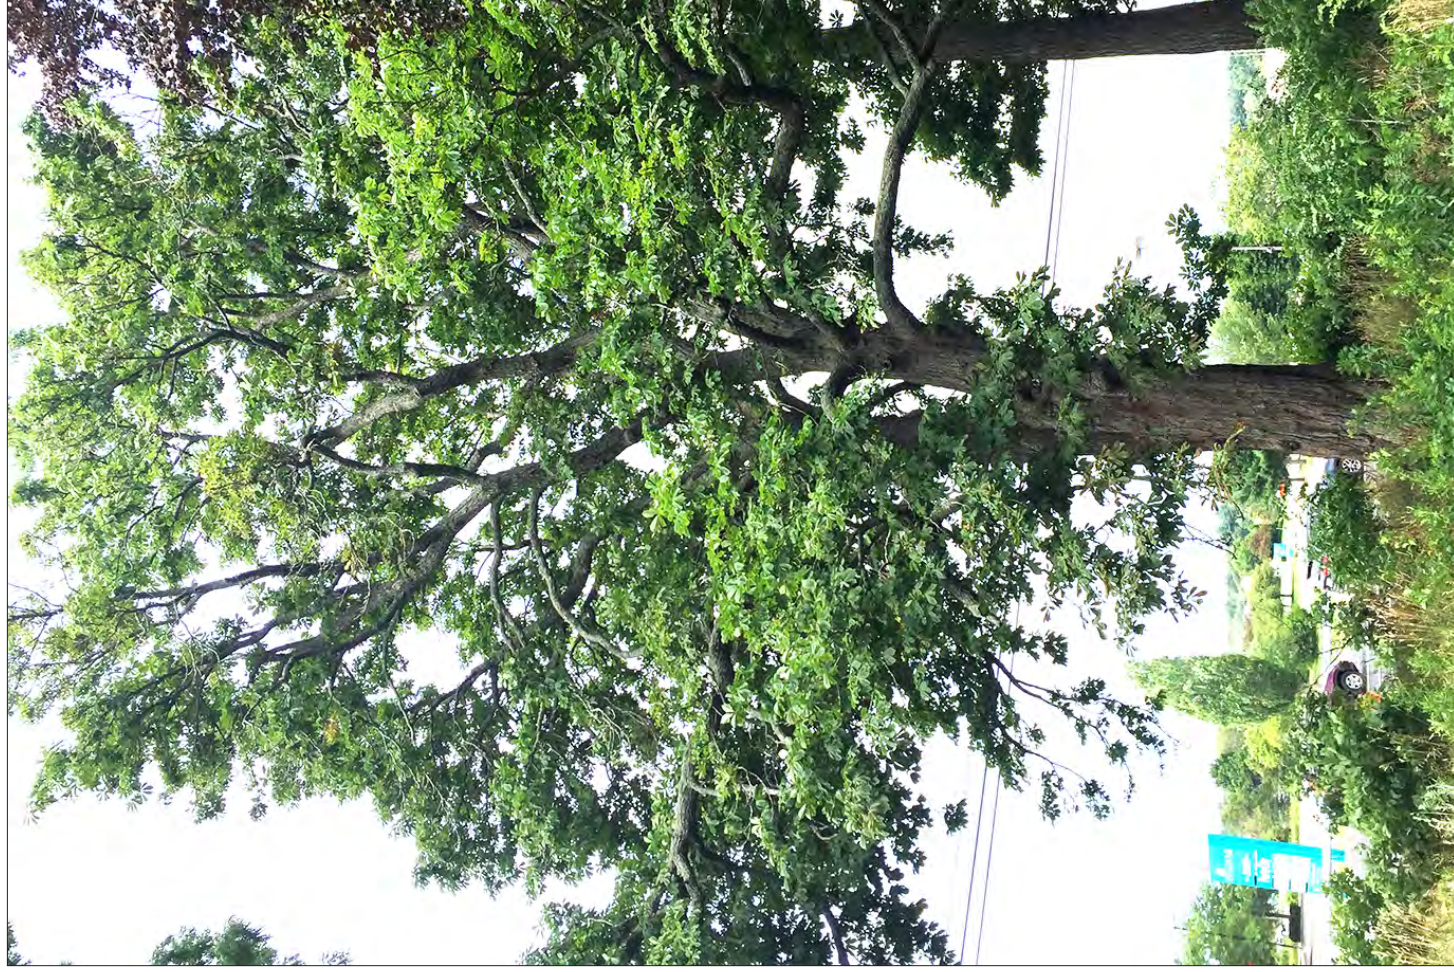
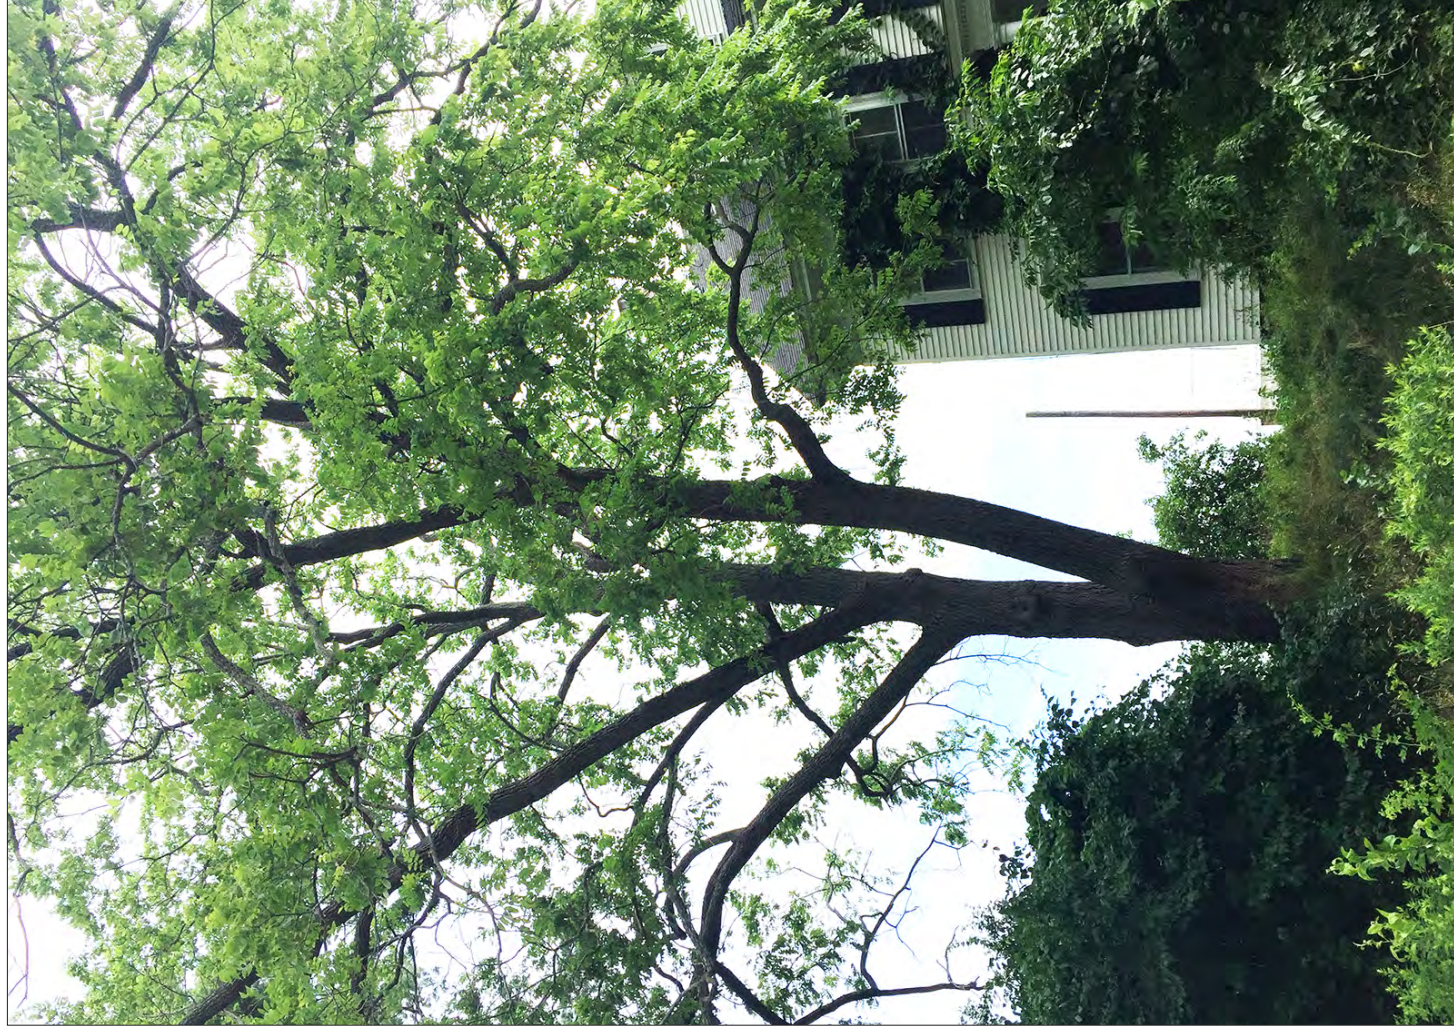
<p>We request that the beech tree be saved as the previous developer had agreed to do before his project fell through. It will add beauty to your new buildings and give your employees and customers a beautiful spot and view to enjoy.</p>
19 & 20	<p>Photo of two mature trees, one by Woodbury Avenue beside the beech tree (photo 19), the other by the corner of the farmhouse (photo 20).</p> <p>We understand that new construction needs to take place and saving all the mature trees may not be possible. However, Woodbury Avenue has been stripped of most of the earlier natural beauty of rural Newington leaving the landscape bare and commercial looking.</p> <p>The corner of your property will stand out as a mini park for employees and customers to enjoy if you can save as many of the mature trees you have inherited as possible. These trees are magnificent, and no other property has anything similar.</p>
