# Newington Historic District Commission – DRAFT MINUTES

## Louis deRochemont House (1876)

### REPORT ON THE OLD PARSONAGE NEWINGTON, NEW HAMPSHIRE

JAMES L. GARVIN  
OCTOBER 22, 1999

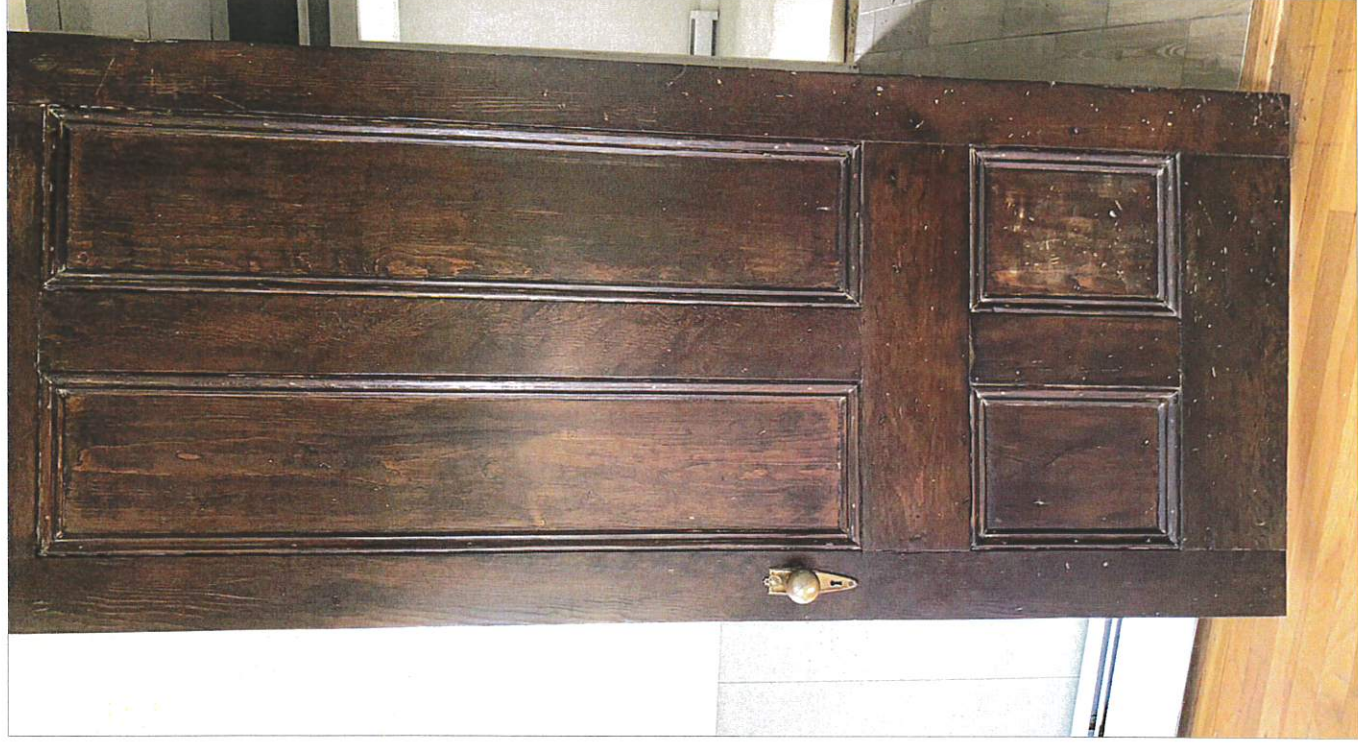
Photo 10

10	<p>Photo of one of the many original doors that still exist. The doors are a Greek Revival style of 4 panels with longer panels on top. The doors do not have beveled panels. Instead the panels are flat with molding to add detail. Original hardware exists on many of the doors.</p> <p>We would like to preserve two of the doors that are in the best shape, with their hardware, and the least layers of paint. These could be used in the renovation of another publicly or privately-owned building.</p>
11	<p>Photo of the baluster, balustrade, and bannister details. How many kids flew down that bannister over the years! The front stairway is one of the few remaining original architectural features in the house.</p> <p>We would like to save the entire balustrade and bannister, which could be used in the renovation of another building to preserve this early design.</p> <p>The tenons on the bottom of the balusters should not be cut at stair level. Rather the stair step itself can be cut so as to retain the integrity of all the tenons.</p>

- F) Item #10 – (Two Doors). We will accommodate that request.
- G) Item #11 – (Entire Balustrade and Bannister). We will accommodate that request.
- H) Item #12a and 12b – (Newel Post). We will accommodate that request.

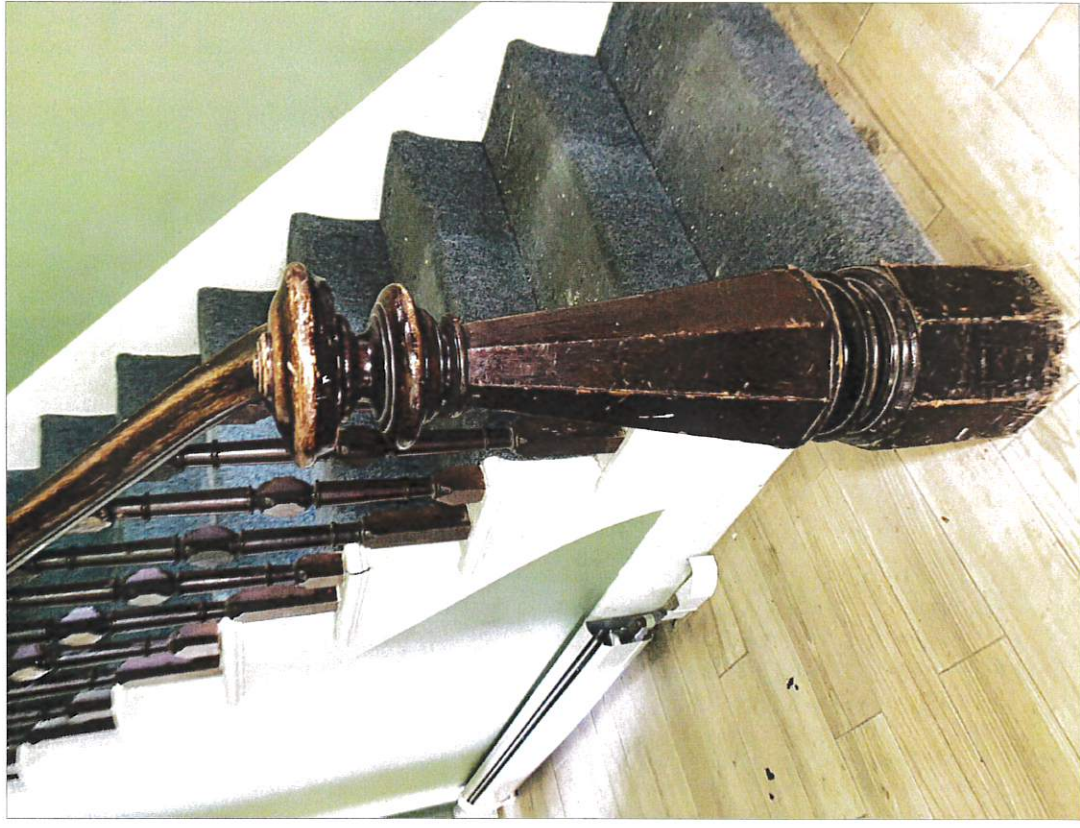
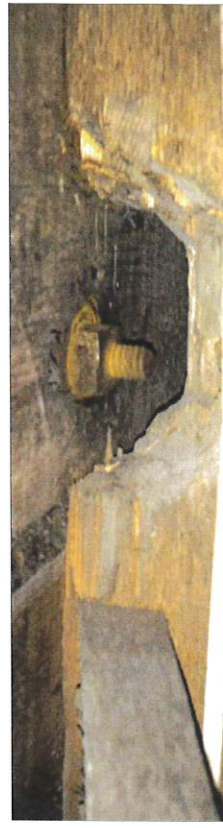
Photo 12a

12a 12b	<p>Photo of the original newel post, which its unique and faceted design.</p> <p>We would like to save the newel post. It is OK if it comes away from the tenon in the bannister. The newel post can be removed by unfastening the screw accessible under the floor in the cellar (photo 12b). The bottom tenon of the newel post should not be cut.</p> <p>The hope is that the entire balustrade, bannister, and newel post could be used in the renovation of another building.</p>
13	<p>Photo of one of the 2 over 2 sash windows, which retain their historic window moldings, hardware, sash weights, ropes and pulleys. This historic design was recently preserved in the Beane Farm on Nimble Hill Road that was renovated in 2018-2019.</p> <p>We would like to preserve two of the windows in the best shape. The whole window unit, trim and all can be cut from the wall. They could be used in the renovation of another building or kept as an example of the early ingenuity in window function.</p>

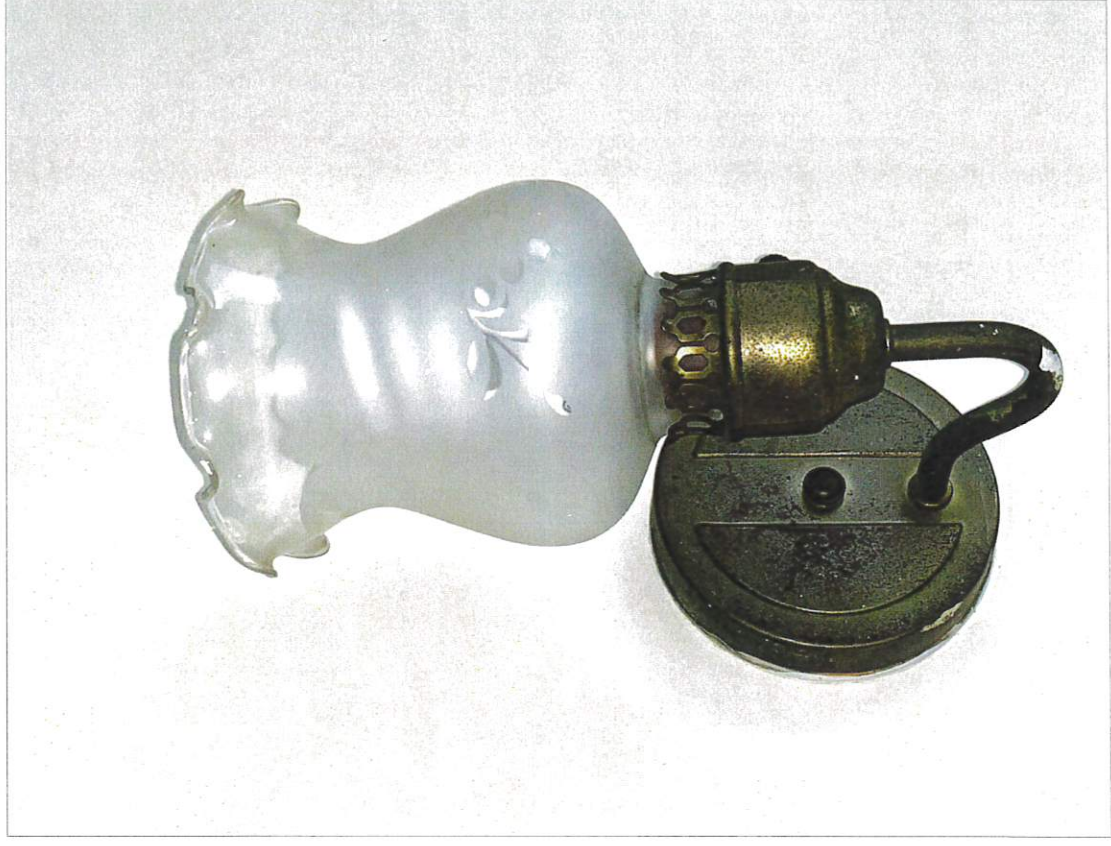
Photo 14

14	<p>Photo of one of the sconce lights.</p> <p>We would like to preserve the three sconces and shades in the upstairs hallway.</p>

- I) Item #13 (Two Windows). We will accommodate that request.
- J) Item #14 (Three Sconces). We will accommodate that request.
- K) Item #15 and 16 (Stone Foundations). We will accommodate that request based on the conditions above.

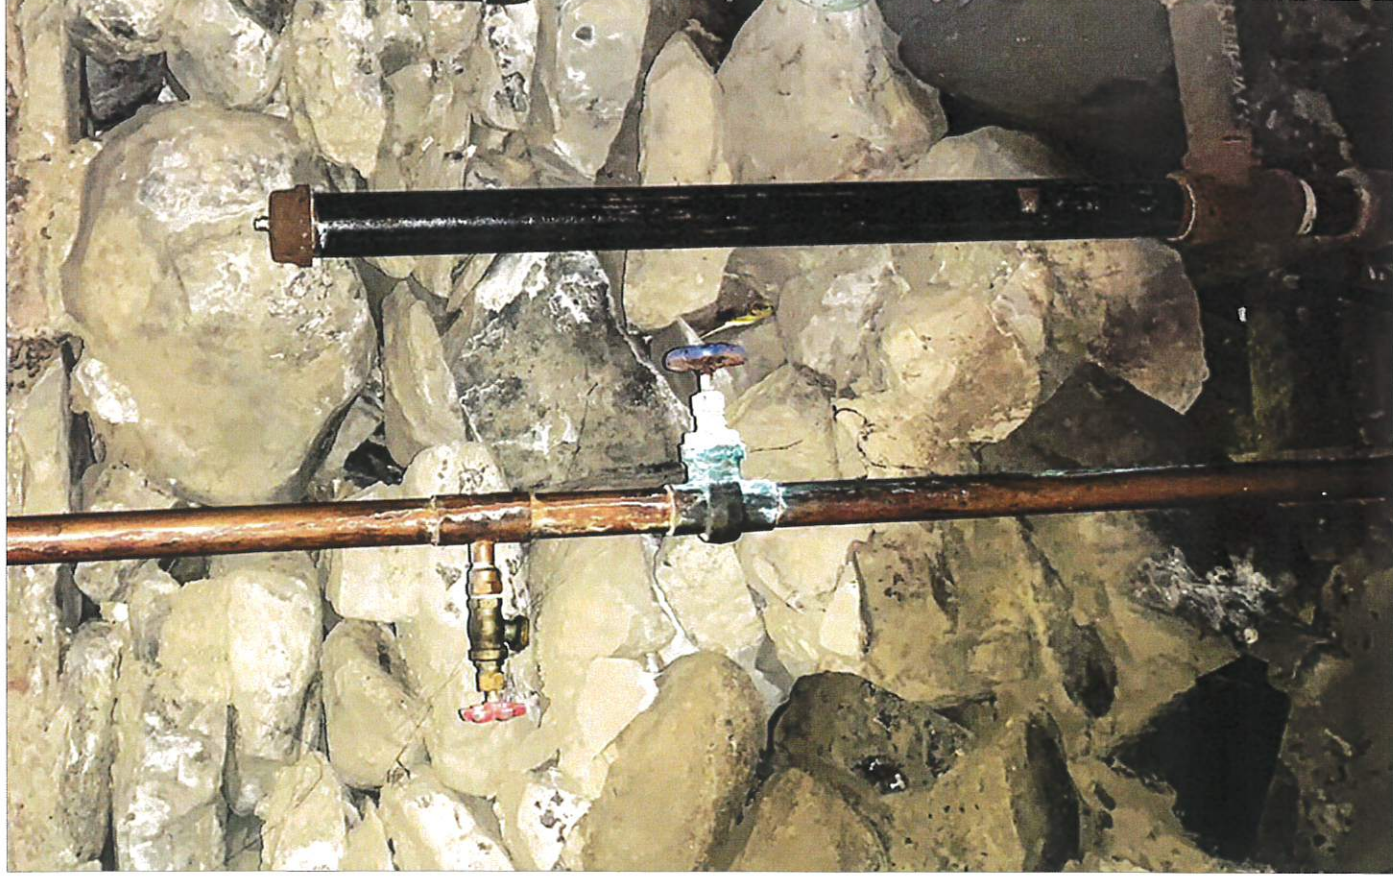
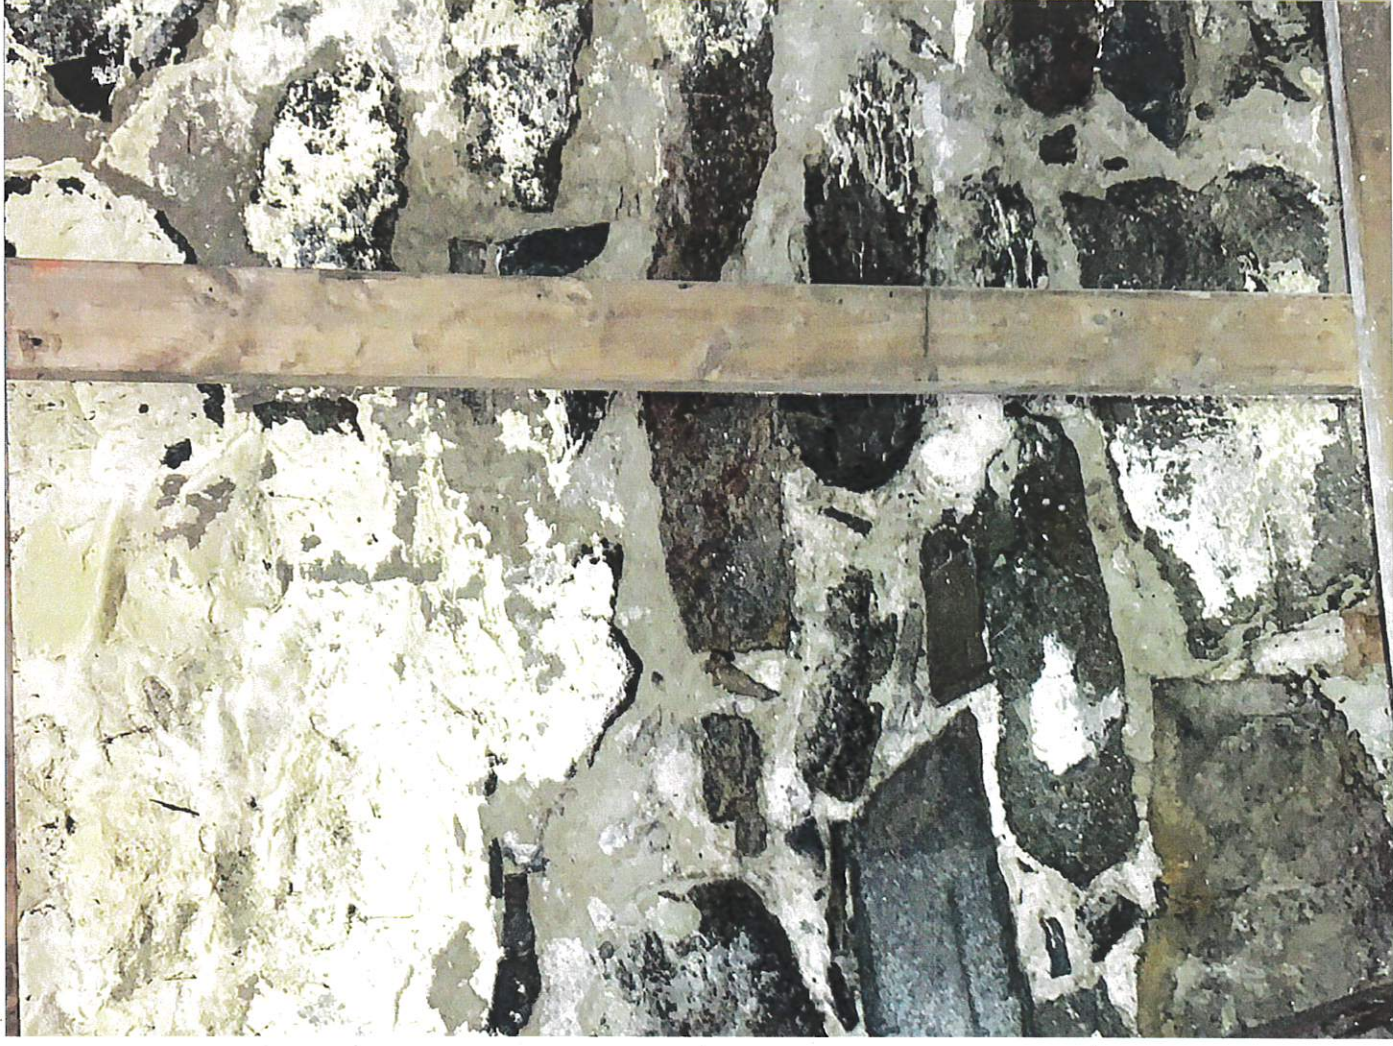
Photo 15

15 & 16	<p>Photo 15 taken in the cellar furnace room shows the backsides of the farmhouse foundation stones. These are all good-sized stones, many with a rounded shape that are perfect for stonewall restoration.</p> <p>Photo 16 shows another section of the foundation with mortar between the stones and what looks to be paint or lime wash on the surface of many stones.</p> <p>We have been emailing with a mason about reuse of the cellar foundation stones. He asked whether there appear to be any fibers in the white wash or lime mortar because that might indicate that the white material contains asbestos. The initial report indicates no asbestos around the stone, but that will be confirmed and certified after all the asbestos is removed from the building.</p> <p>We acknowledge that some stone may not be salvageable during demolition. Based on the age of the stone, some types of stone could crumble during removal. It may have good integrity when joined together, but during the demolition process there could be an issue.</p> <p>If no asbestos is present on the stones, the mason says the stones can either be wire brushed, which is very labor intensive, or if the layer is not too thick, he has built wall with lime coated stones and sandblasted afterwards using tarps to catch debris. For the current project we are only interested in salvaging and collecting the stones, how to remove the white material can be a future problem.</p> <p>We would like to preserve as many of the foundation stones are possible. We are not interested in the bricks. It is OK if the wall sections fall apart, the shape of the foundation wall does not need to be preserved. The stonemason will need to separate the stones by size anyway before a new wall can be laid.</p> <p>We would like to be present when the work is underway to gauge any difficulties. Our hope is that the excavator/contractor that you use can transport the stones to a laydown area in the historic district where the stones will be stockpiled for future use.</p>

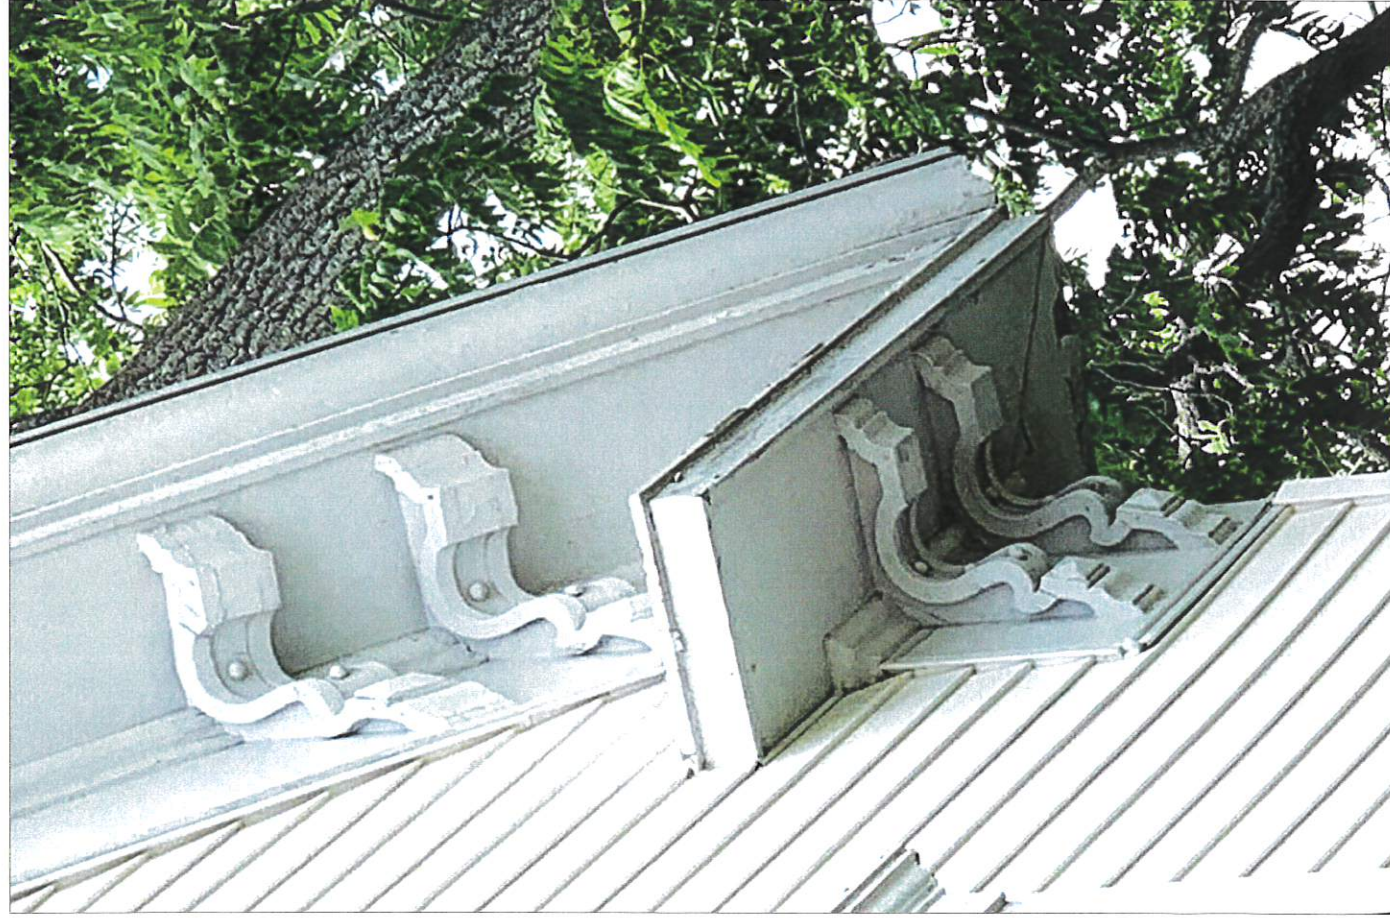
Photo 17

17	<p>Photo of the decorative Italianate detailing of paired brackets under both the eaves and the cornice returns on the gable end.</p> <p><b>We would like to preserve two of the brackets that are in the best shape and have the clearest details. These will likely not be reused in a building restoration project but could be used as templates to create replicate brackets in the future.</b></p>
18	<p>Photo of beech tree by Woodbury Avenue. This property has some great mature landscaping features, such as this outstanding beech tree.</p>

- L) Item #17 (Two Brackets). We will accommodate that request.
- M) Item #18, 19, and 20 (Trees). We all have an interest in saving trees and accommodating this request. LEVEL5 and Northeast CU will try to save the trees pending the site plan layout, but we cannot accommodate and / or agree to this request.

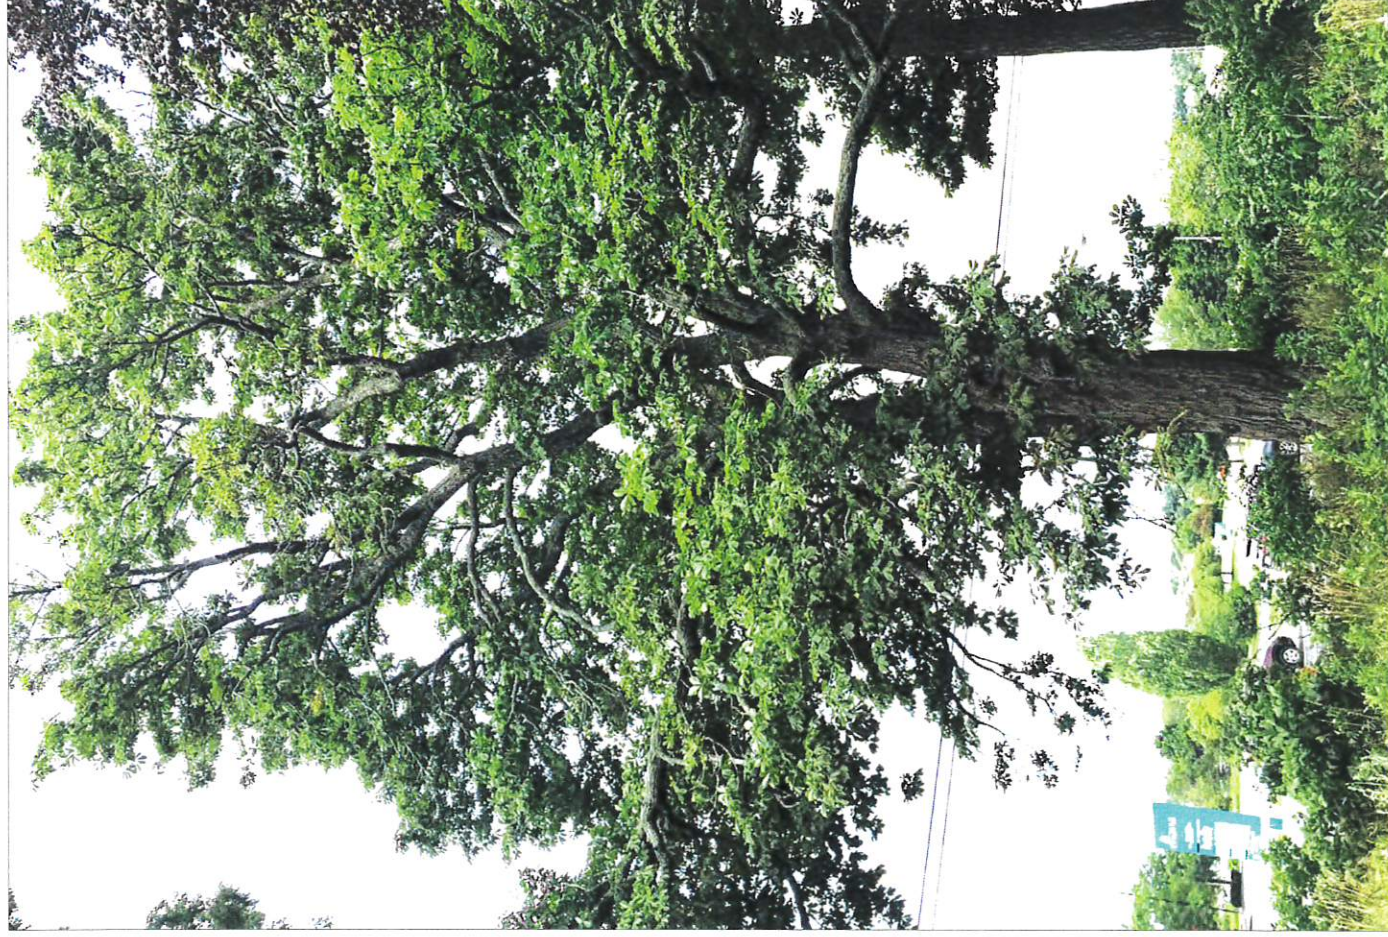
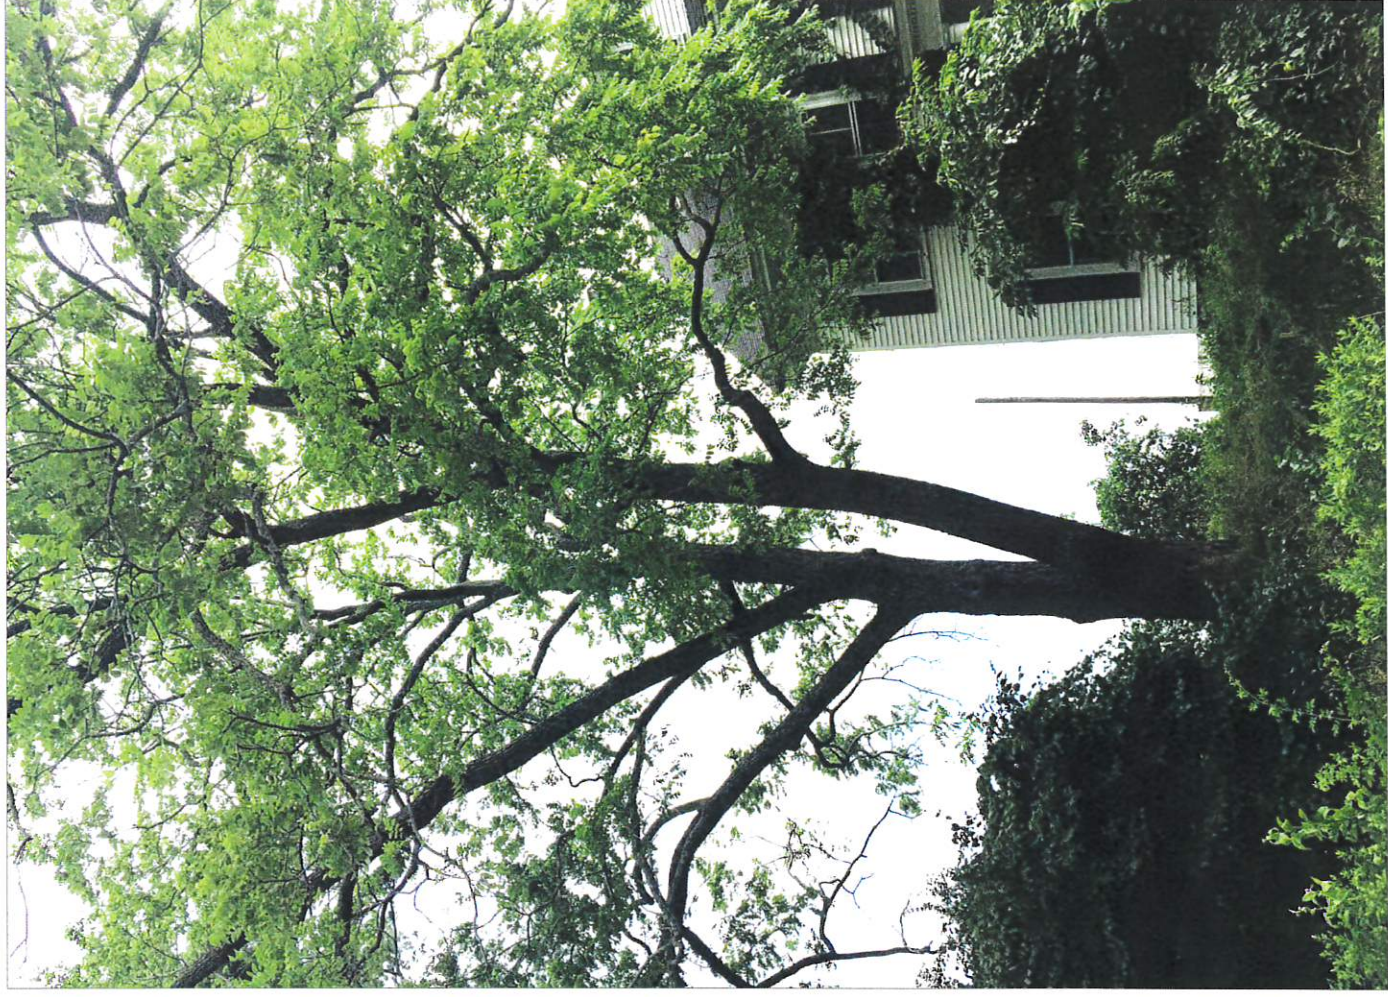
Photo 19

<p>We request that the beech tree be saved as the previous developer had agreed to do before his project fell through. It will add beauty to your new buildings and give your employees and customers a beautiful spot and view to enjoy.</p>
19 & 20	<p>Photo of two mature trees, one by Woodbury Avenue beside the beech tree (photo 19), the other by the corner of the farmhouse (photo 20).</p> <p>We understand that new construction needs to take place and saving all the mature trees may not be possible. However, Woodbury Avenue has been stripped of most of the earlier natural beauty of rural Newington leaving the landscape bare and commercial looking.</p> <p>The corner of your property will stand out as a mini park for employees and customers to enjoy if you can save as many of the mature trees you have inherited as possible. These trees are magnificent, and no other property has anything similar.</p>
