Newington Historic District Commission – FINAL MINUTES

Tuesday September 18, 2018

REPORT ON THE OLD PARSONAGE NEWINGTON, NEW HAMPSHIRE

JAMES L. GARVIN
OCTOBER 22, 1999

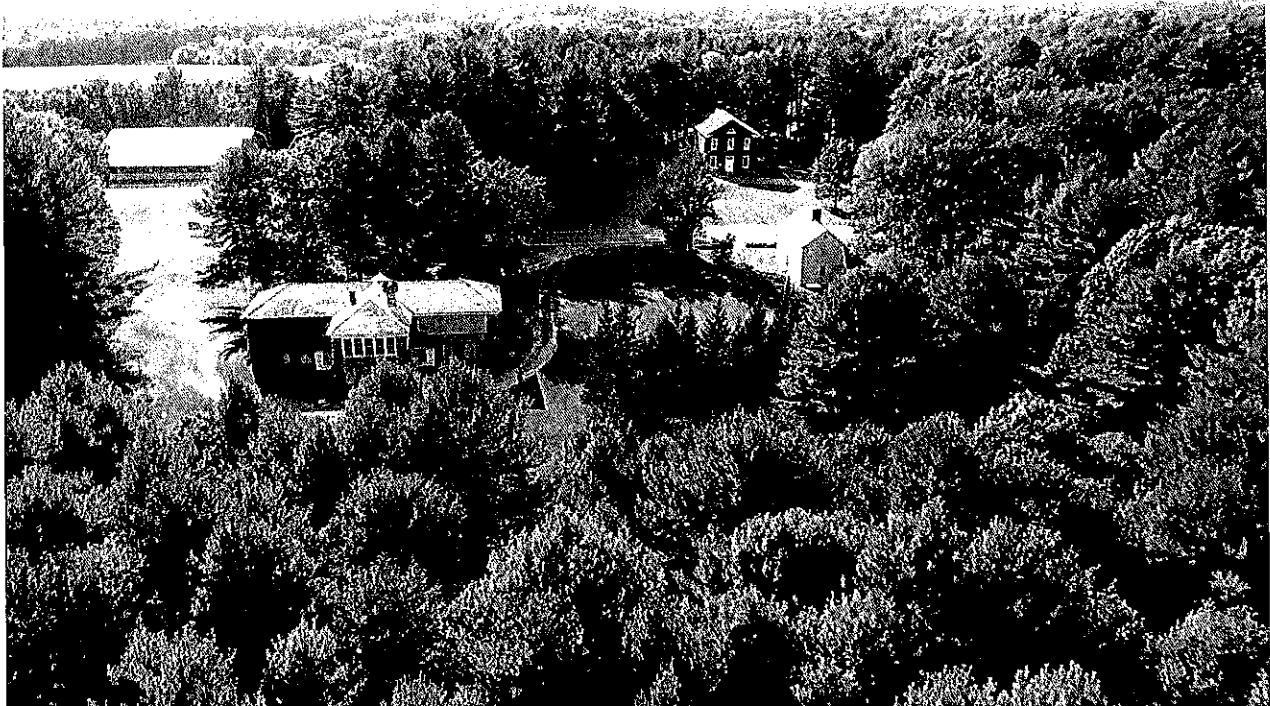
Area of tree cutting for 2018 bids:

- Fours pines in front of Old Stone School, plus trimming the oak tree
- Removal of cedars, and small brush trees by lilacs in front of the Old Parsonage
- Removal of small ash, trimming of large ash overhanging Old Parsonage rear roof, removal of up to 5-6 pines along New Road.
- Removal of two bull pines and up to 25 or so smaller firs to the East of the Old Parsonage and northeast of Old Stone School.
