Technical Memorandum

Subject: Seacoast Reliability Project (RPR# 6528; NAE-2015-00665)

The following memorandum presents information on four newly identified historic stone walls documented during the pre-construction stone wall survey conducted by surveyors for Eversource Energy's Seacoast Reliability Project ("Project"). A brief description of the stone walls is provided along with locational information, photographic documentation, and proposed treatment plans. The walls have been added to Project construction map sheets.

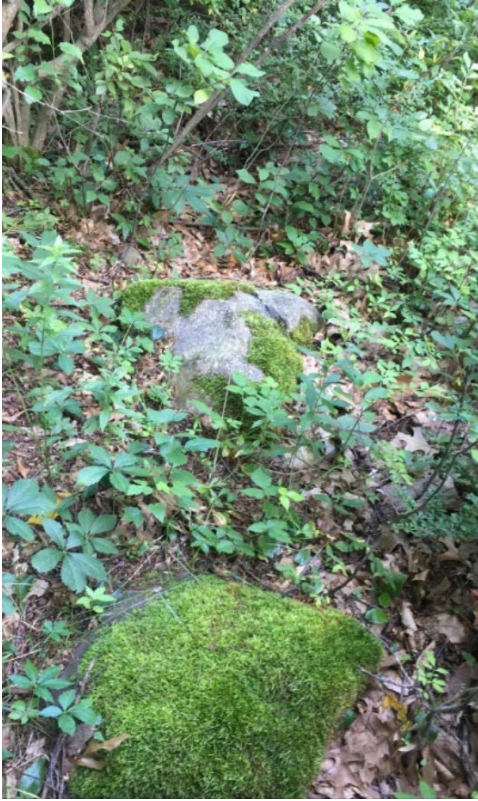
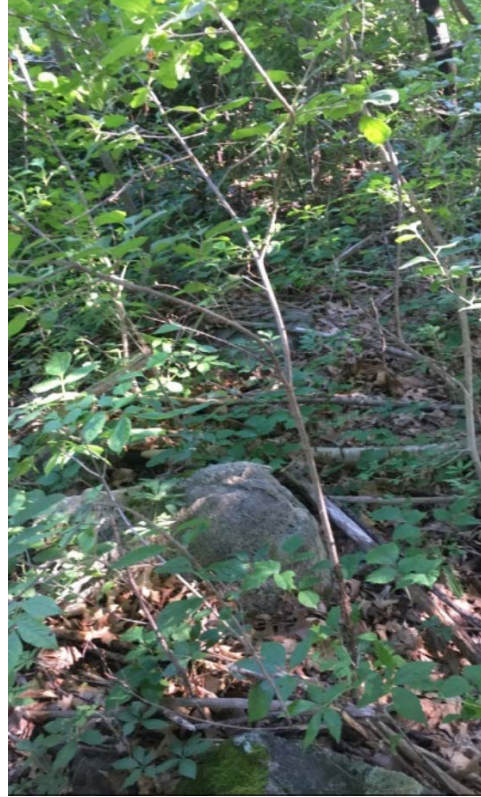
Figures 3 (left) and 4 (right). Stone wall WP-42B, facing northwest (left) northeast (right).

Stone wall segment WP-42B is located on the south side of the ROW, east of Nimble Hill Rd and north of Hannah Lane (see Figures 1–4). The wall consists of two small segments, positioned at right angles, and is covered by dense vegetation (see Appendix A, Sheet 1). Both segments of the wall are simple, linear stone alignments and consist of a single course of native stones that vary in size from approximately one to three feet in diameter. The wall lacks integrity and may have been affected by past activities on the ROW; many of the stones are either buried or are flush with the ground surface. An existing breach, measuring approximately 12 feet wide, is located near the northwest corner of the wall.

Specifically, impacts to stone walls WP-42B and WP-46 are expected to be avoided by not traversing the wall. Access around stone wall WP-47 will be managed by using timber matting to temporarily bridge over the wall and stone wall WP-48 will either be avoided, or timber matting will be used to elevate the work pad above the wall.

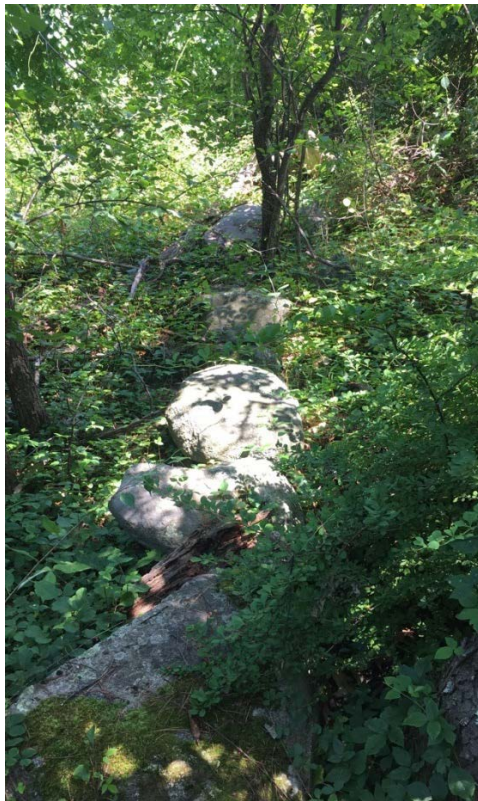
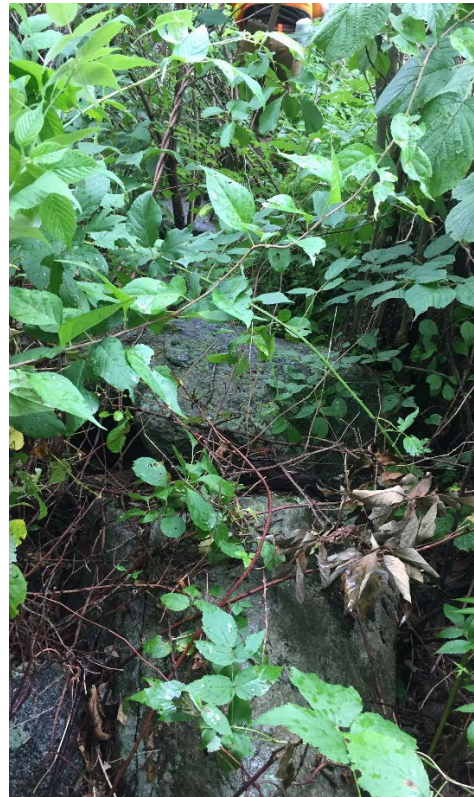
Figures 5 (left) and 6 (right). Stone wall WP-46, facing northeast.

Stone wall segment WP-46 is located on the southwest portion of the ROW, west of the Spaulding Turnpike and south of the newly constructed on-ramp (see Figures 1–2; 5–6; Appendix A, Sheet 2). The stone wall is an unmaintained common boundary wall, most likely truncated by the construction of the Turnpike. The stone wall consists of one to two courses of loosely stacked native stone and is characterized as a minimal stone

wall in a single alignment with numerous dislodged stones. The wall is perpendicular to the ROW and is covered by dense invasive vegetation.

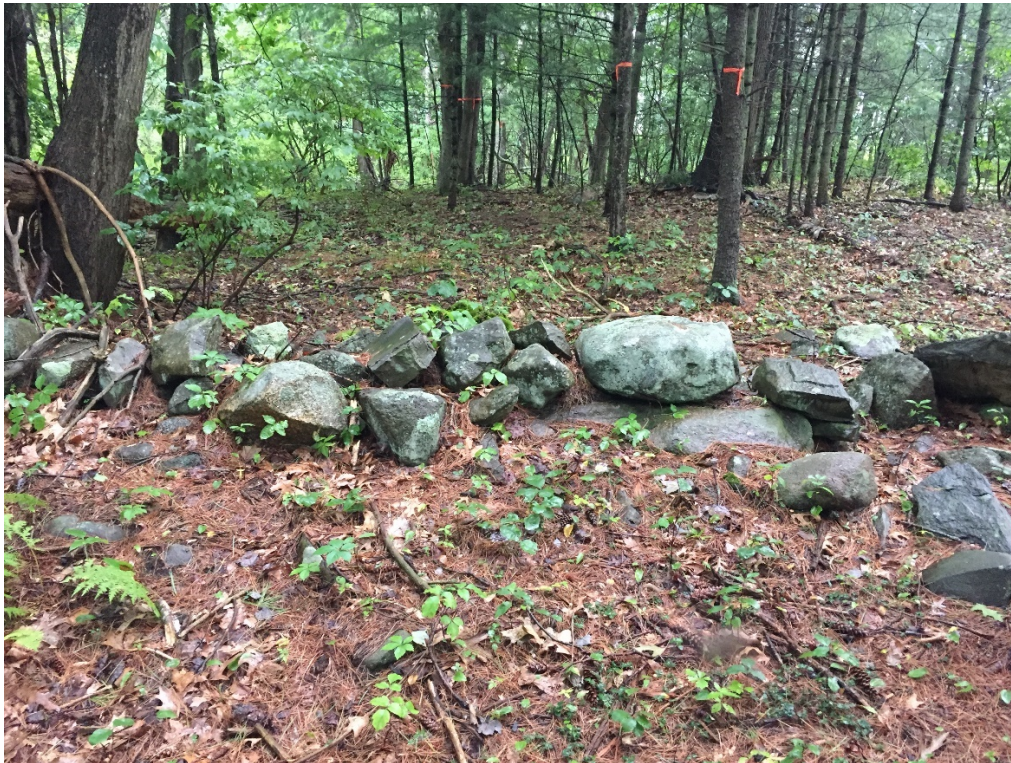
Figure 7. Stone wall WP-47, facing northwest.

Stone wall segment WP-47 is located west of the Spaulding Turnpike and east of Arboretum Road (see Figures 1–2; 7–8; Appendix A, Sheet 3). The stone wall is an unmaintained common boundary wall, most likely truncated by the construction of the Turnpike. The stone wall is situated on a small raised landform surrounded by wetland and runs perpendicular to the ROW. The surrounding area is forested with sparse understory vegetation. The wall is composed of one to two courses of native stone and is characterized as a minimal stone wall in a single alignment with numerous dislodged stones.

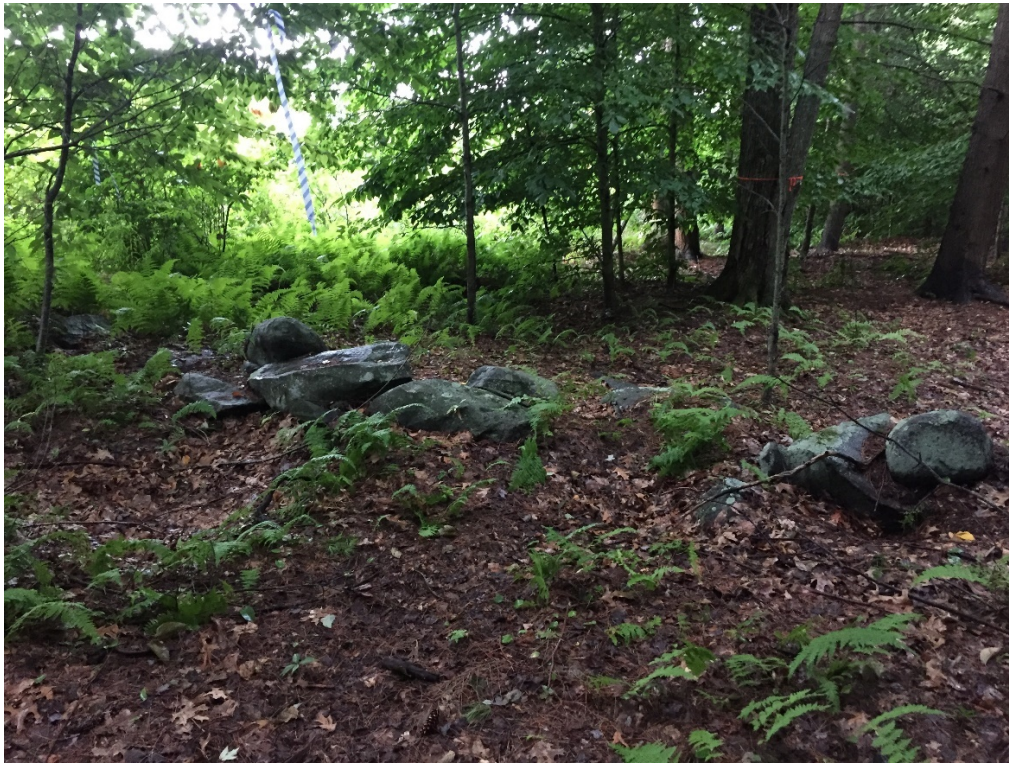
Figure 9. Stone wall WP-48, facing northwest.

Stone wall segment WP-48 is located west of the Spaulding Turnpike and north of Pease Boulevard (see Figures 1–2; 9–10; Appendix A, Sheet 4). The stone wall is an unmaintained common boundary wall, most likely truncated by the construction of the Turnpike. The stone wall is located on a forested upland with sparse understory vegetation. The wall is composed of one to two courses of native stone and is characterized as a minimal stone wall in a single alignment with numerous dislodged stones.

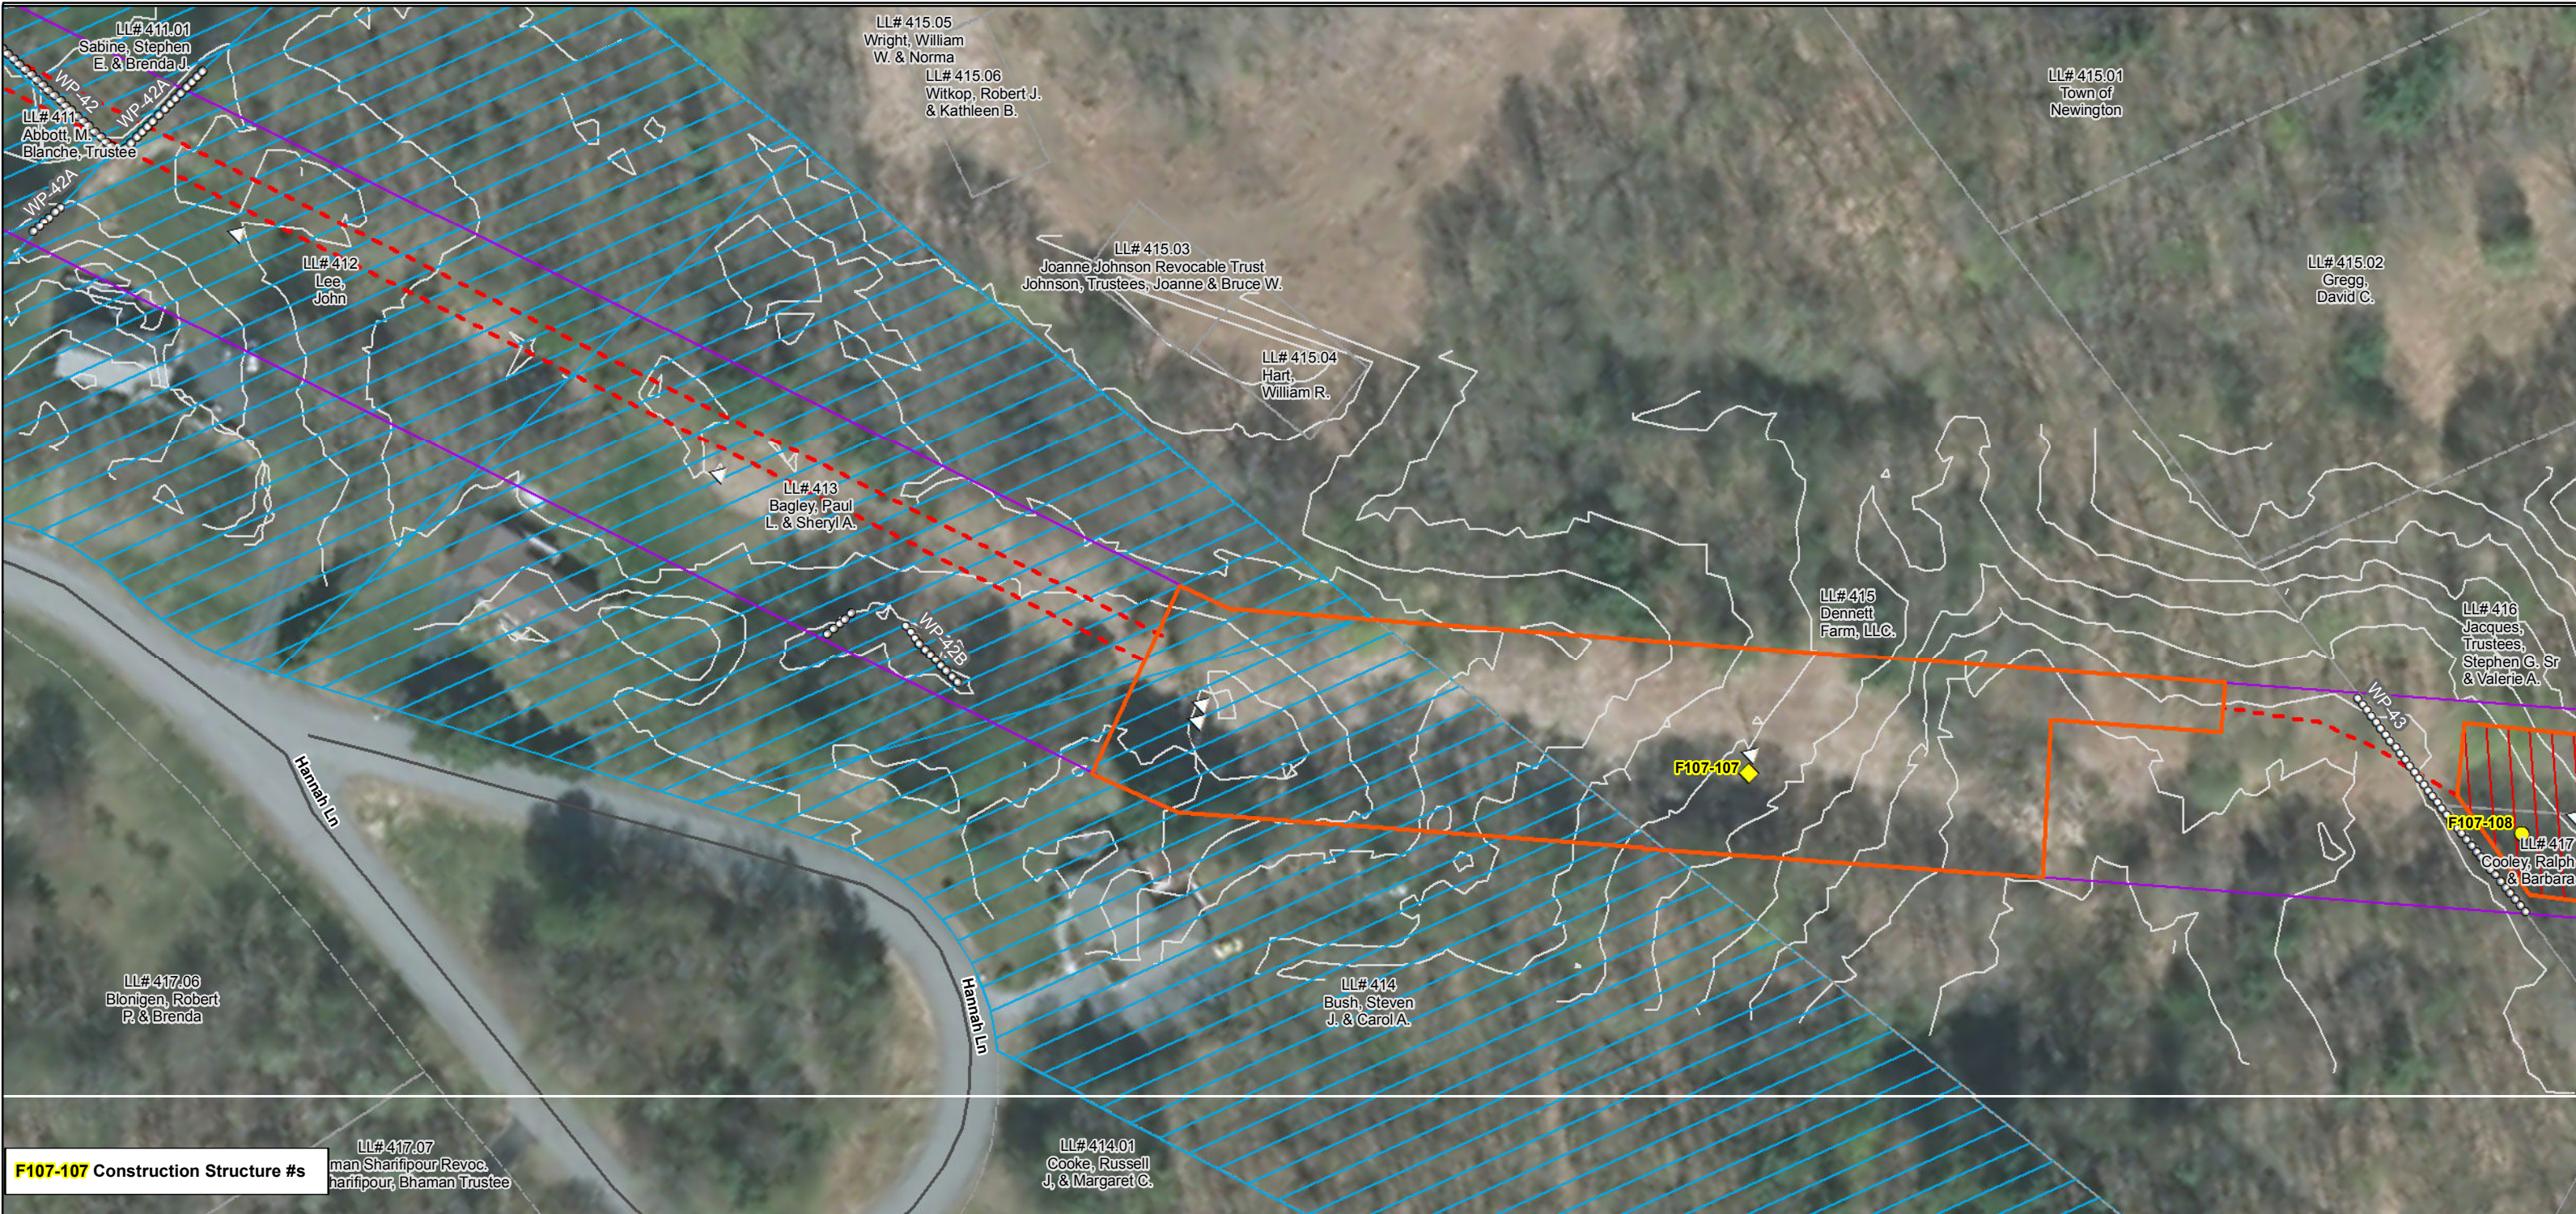
Appendix A:
Newly Identified Stone Walls
on Project Construction Maps

All four stone walls or stone wall segments are located within the Project right-of-way (ROW) in the Town of Newington, New Hampshire. The new resources were labeled WP-42B, WP-46, WP-47, and WP-48 to conform with the existing naming convention. None of the newly identified stone walls are property boundary walls, nor are they located within the boundaries of any inventoried historic districts or are associated with any known historic resources.
